**Service Information Letter**

<b>Title: Software Upgrade digital ASI and ALTI</b>		
<b>AG-SIL-2018-01-B-EN</b>		<b>Compliance Category:</b>
<b>Applicability</b>		<b>A – MANDATORY B – RECOMMENDED C – OPTIONAL</b>
<b>Aircraft type &amp; model: Any AutoGyro type, fitted with digital ASI (Software Version 2.16 and older) and ALTI (Software Version 2.12 and older)</b>	<b>Betroffene Werknummern: Any AutoGyro type, fitted with digital ASI (Software Version 2.16 and older) and ALTI (Software Version 2.12 and older)</b>	
The maintenance manual to be referenced is this stated or subsequent issue.		As per AutoGyro website
This form is the response from AutoGyro GmbH either against a problem found in the product in service requiring a containment or rectification action, or as service information for aircraft modification incorporation. For help, contact AutoGyro on 49(0)5121 88056-00, or email <a href="mailto:airworthiness@auto-gyro.com">airworthiness@auto-gyro.com</a> .

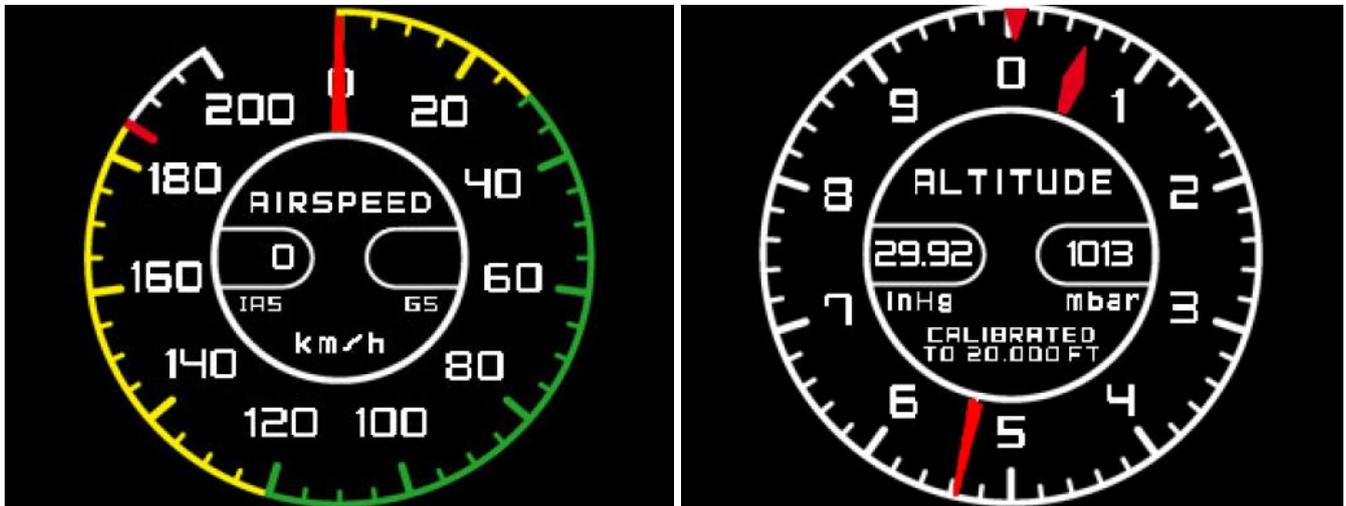
**Original instrument display**

AutoGyro has listened to market feedback regarding the visual appearance of instrument displays, and of the device reliability. The company decided to offer an upgrade to owners that makes the devices easier to read in different lighting conditions, and improves the operational reliability. Any device with a display as shown below may be upgraded to software level 2.17.
