| <b>Title: Coolant level indicator interpretation</b> | | |
| <b>AG-SIL-2018-03-A-EN</b> | | <b>Compliance Category:</b> |
| <b>Aircraft type &amp; model:</b><br><b>MTOSport 2010 (where fitted) and 2017</b> | <b>Affected aircraft serial numbers:</b><br><b>Any MTOSport fitted with an aluminium coolant tank with integral viewing window</b> | |

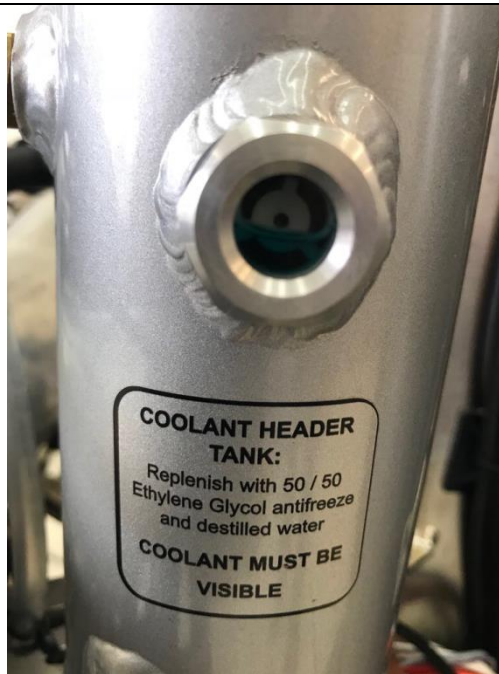
The integral viewing window built into the coolant header tank is designed to permit the inspecting person to determine that adequate coolant is present in the coolant tank before aircraft operation. During aircraft assembly it was found that sometimes the coolant hangs in a meniscus in the viewing window. This may lead the inspector to believe that adequate coolant is present, when the actual coolant level is low.

If the window is clear, or there is a meniscus of coolant showing in the window as in the photo, then the coolant level is considered low and must be topped up.

*Photo of viewing window, with meniscus of coolant showing.*

Coolant must be topped up with the correct 50/50 mix of ethylene glycol and distilled water. Recheck the level after topping up, and remember to replace the coolant header tank cap.
