| <b>Title: MTO2017 Thermostat Oil temperature Sensor Re-positioning</b> | | |
| <b>AG-SB-2021-04-B-EN</b> | <b>Effective Date:</b> 16 June 2021 | <b>Compliance Category:</b><br><br><del>A – MANDATORY</del><br><b>B – RECOMMENDED</b><br><del>C – OPTIONAL</del> |
| <b>Aircraft type &amp; model:</b><br><br>AutoGyro MTO2017 | <b>Affected Serial number(s):</b><br><br>AutoGyro MTO2017 912/914 fitted with an oil thermostat II incorporating an oil temperature sensor | |

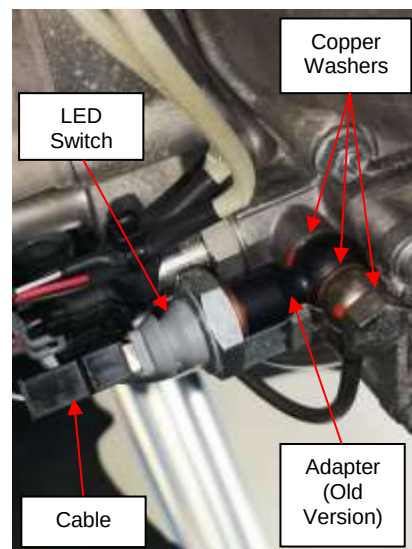
4. Remove the low oil pressure LED switch & adapter from the engine (Pic. 4).
5. Remove the switch from the adapter. Clean the threads of the sensor and the (now open) engine mounting position with Loctite 7063. Assemble the switch into the new adapter (Pic. 3) using 1 x copper washer (Pic. 3). NOTE: The adapter has been modified – the item in Pic. 3 is correct, the item in Pic. 10 is the older version.
