| <b>Title: Cavalon 915iS Lower Engine Mounting Nuts</b> | | |
| <b>AG-SB-2021-01-B-EN</b> | <b>Effective Date:</b> 20 April 2021 | <b>Compliance Category:</b><br><br><b>A – MANDATORY</b><br><b>B – RECOMMENDED</b><br><b><del>C – OPTIONAL</del></b> |
| <b>Aircraft type &amp; model:</b><br><br>AutoGyro Cavalon | <b>Affected Serial number(s):</b><br><br>AutoGyro Cavalon fitted with a Rotax 915iS engine | |

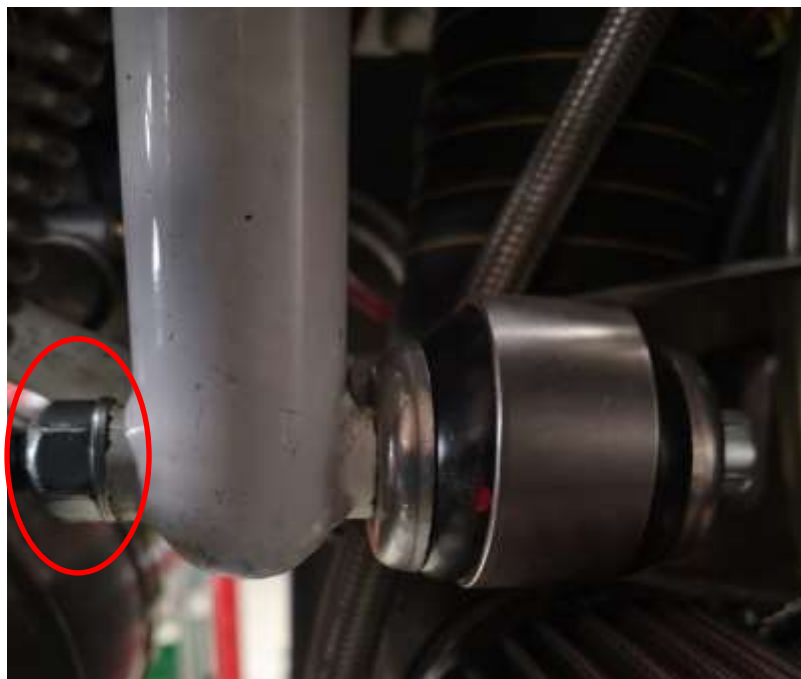
Engine mount assembly with SI full metal M10 nut

1. Gain access to the engine mountings by removing the upper and lower engine cowlings in accordance with the AMM job card 52-00-00 4-1.
2. Determine whether Binx M10 nuts (43511) or SI Nyloc M10 nuts (20183) are assembled on any of the lower engine mounting bolts. If SI full metal M10 nuts are fitted, no further action is required.
3. If Binx M10 or SI Nyloc M10 nuts are fitted, then replace with M10 SI full metal nuts (23630) for zinc plated engine mounting bolts in accordance with Job Card 71-20-00 8-1 of the respective AMM. Tighten well, noting that it is extremely difficult to access with a torque wrench. Target tightening torque 39Nm. Ensure a minimum of 1.5 threads of the bolt end are protruding from the nut once torqued.
4. Carry out a loose article and tool check.
5. Refit any previously removed cowlings in accordance with the respective job card.
