| <b>Title: Torque / Washer Check L/H Lower Engine Mount Rotax 915 iS</b> | | |
| <b>AG-SB-2023-04-B-EN</b> | <b>Effective Date: 09.10.2023</b> | <b>Compliance Category:</b> |
| <b>Aircraft type &amp; model:</b><br><br><b>All aircraft with a Rotax 915 iS engine and a fixed nut on the left lower engine mount</b> | <b>Affected Serial number(s):</b><br><br><b>All aircraft</b> | |

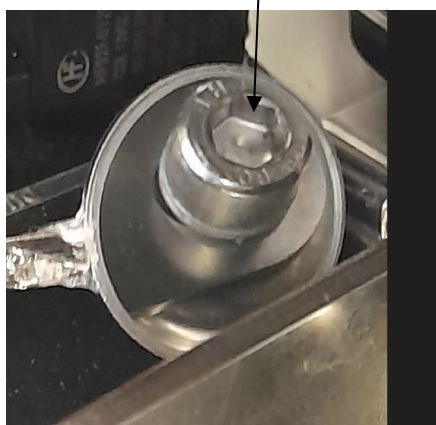
Rotax has factory fitted a nut to the turbocharger plate. AutoGyro now use Nord-Lock washer (PN 48272) in combination with this nut. This washer is only required for Rotax 915 iS engines with a fixed nut. Otherwise, the all-metal nut is used as before. Observe modified tightening torque 56 Nm.

Bolt with Nord-Lock washer

If the aircraft is NOT fitted with a Nord-Lock washer on the lower left hand engine mount, carefully loosen the nut and remove the bolt. Support the engine with a crane or similar if necessary. Install the Nord-Lock washer (convex side facing bolt head) and put the bolt back in, release the engine from the crane if this has been done and torque the bolt with 56Nm.

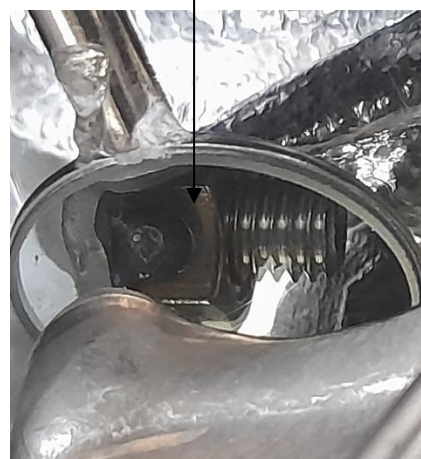
Fixed nut on the turbo charger bracket
