## Title: Garmin G3X Firmware Update For Rotax 915iS

AG-SIL-2021-04-EN

AutoGyro Cavalon 915iS & MTO2017  
915iS

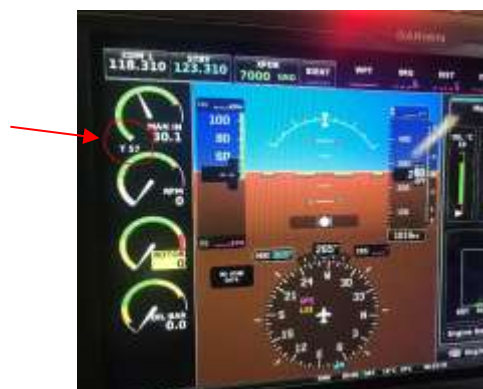
The throttle position or engine power is now displayed as a percentage (value indicated under the manifold display).

For the Rotax 915iS FADEC engine, the engine power display shows the engine power as a percentage when the engine is running. When the aircraft is on the ground and the engine is not running, the engine power display will show the throttle position, which is given as a two-digit value preceded by 'T', e.g. 'T10' for 10% throttle. This is used for the pre-flight checklist of the aircraft.

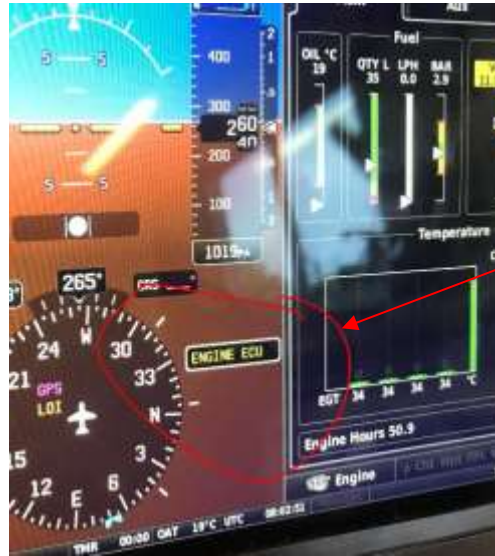
If there is an engine error, typically either LA or LB (LEDs) flash/light up. Now, additional to this, information is also shown in the display (CAS message).

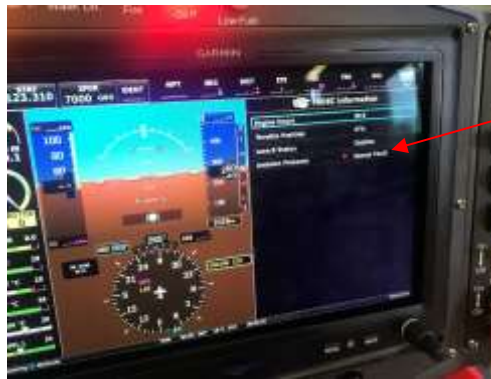
The FADAC Information will now open. The error shown below was provoked by disconnecting the Ambient Pressure sensor plug.
