| <b>Title: Replacement of exhaust manifold</b> | | |
| <b>AG-SB-2023-02-B-EN</b> | <b>Effective Date: 01.04.2023</b> | <b>Compliance Category:</b> |
| <b>Aircraft type &amp; model:</b><br><br><b>Cavalon 915iS</b> | <b>Affected Serial number(s):</b><br><br><b>All Cavalon 915iS</b> | |

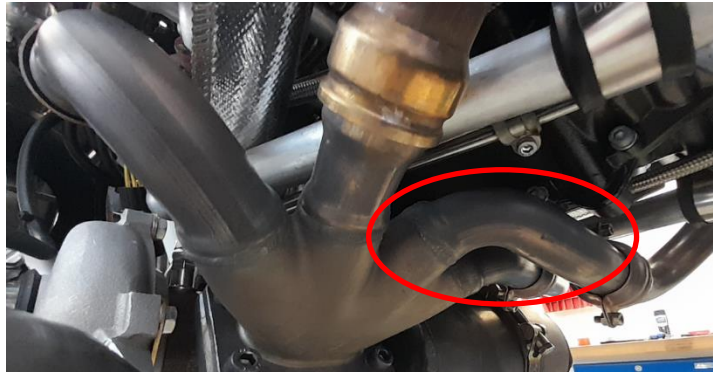
old version part no. 979562:

A number of early generation Rotax 915iS exhaust manifolds were found to have cracked in service. This early generation was superseded in 2021 by a new design, shown in service to be reliable.

It is recommended to replace the old version.

**The exhaust manifold is changed in accordance with the Rotax engine maintenance manual.**

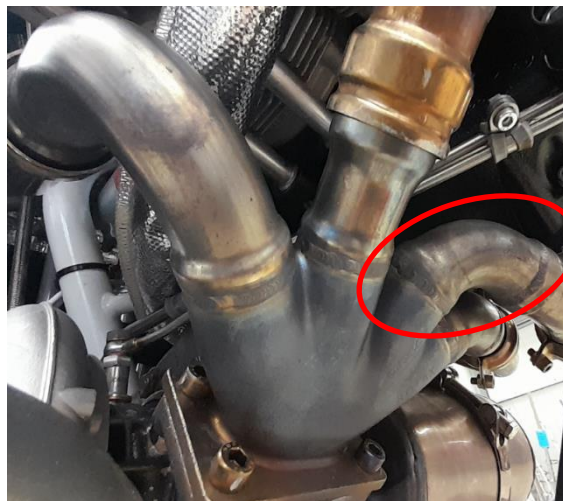
new version part no. 979563:

The difference between both versions is an improved welding at the exhaust connection from cylinder two.

The manifold is Rotax part number 979563.  
AutoGyro provides a kit containing the required service components, part no. 48658, available from the AutoGyro on-line shop.
