| <b>Title: MTO2017 915iS Intercooler Mounting Assembly</b> | | |
| <b>AG-SB-2020-03-B-EN</b> | | <b>Compliance Category:</b> |
| <b>Aircraft type &amp; model:</b><br><br>AutoGyro MTO2017 | <b>Affected Serial number(s):</b><br><br>All MTO2017 fitted with the Rotax 915iS engine | |

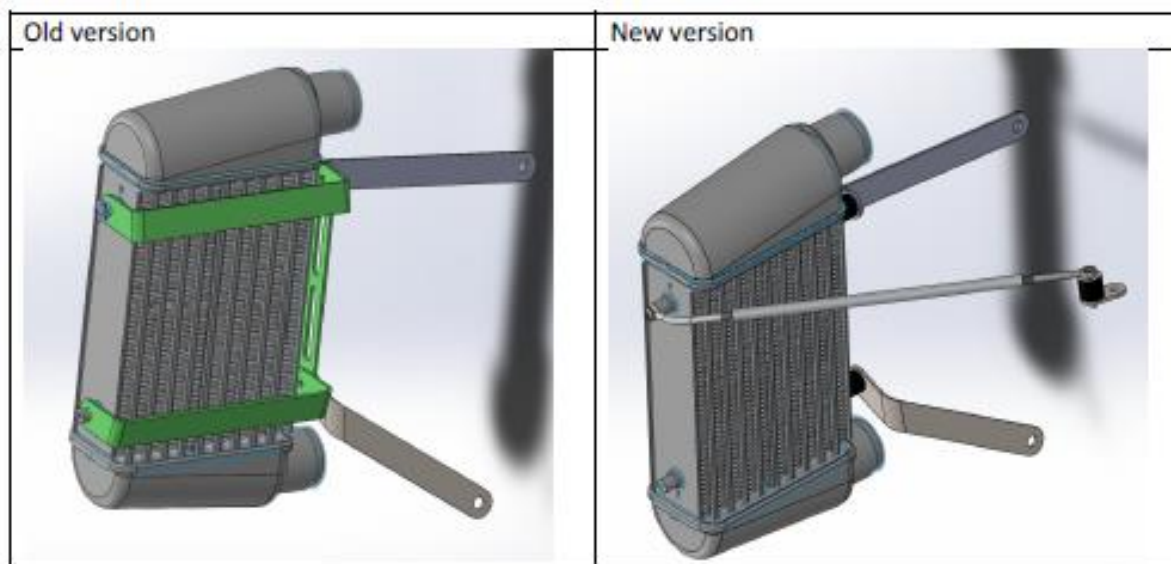
(Pic. 3)

AutoGyro has received feedback from the market that the current 915iS intercooler attachment brackets may, in some cases lead to breakage of the intercooler attachment lugs.

6. Remove the intercooler support frame (Pic. 3 – old version, green items)
7. Ensure the engine is supported and remove the upper and lower engine mounting bolts in accordance with AMM Job Card 71-20-00 8-1.
