**AG-SB-2017-03-B-EN – MT03 control rod****Category B****EFFECTIVE DATE**

This Service Bulletin is applicable for all MT03 and converted MT03 to MTOsport until 12 / 2007, where the control rod is cut diagonally (see fig.1).

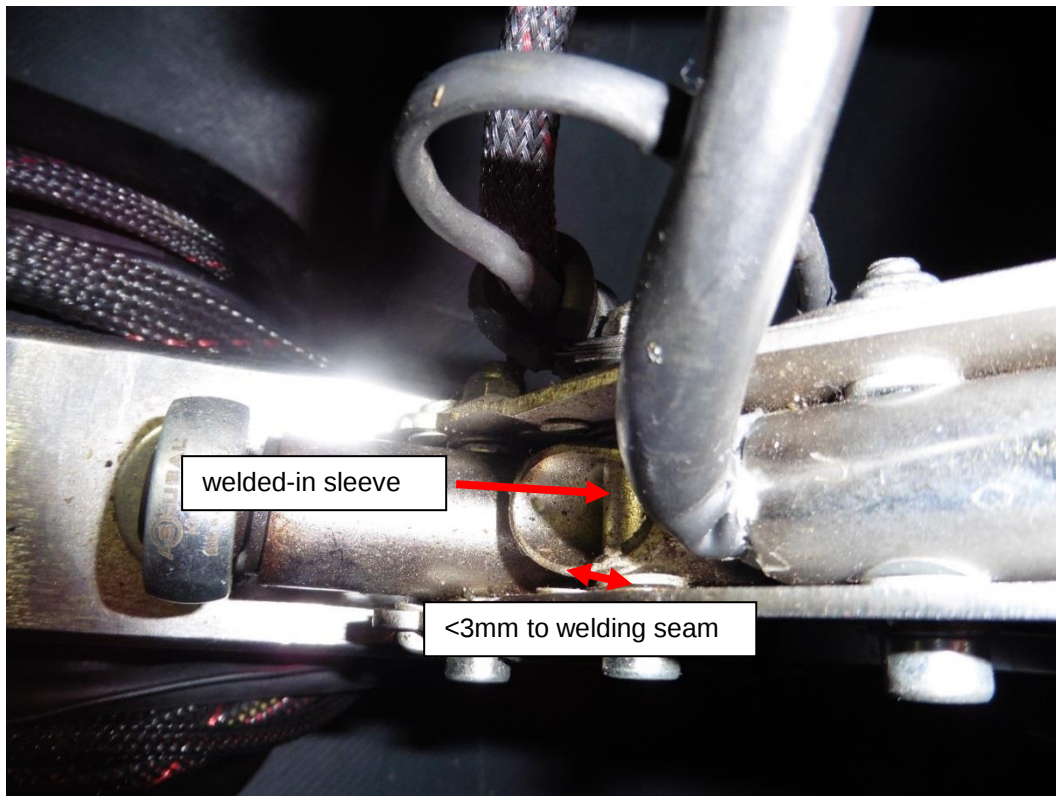
A case was found with a failed weld and subsequent tube failure at the upper control rod joint to the front control stick. Normally this would be found during maintenance or pre-flight inspection, so the purpose of this SB is to highlight the need to check this part.

**Fig. 1: old control rod with diagonally cut**

- Inspect that the welded-in sleeve inside the end of the tube is secure, and no evidence of weld failure.
- Inspect if the control rod has been cut down more than 3mm between the end of the rod and the outer wall of the welding seam.
- Rectification: replace the control rod if cut down limit of 3mm is exceeded.

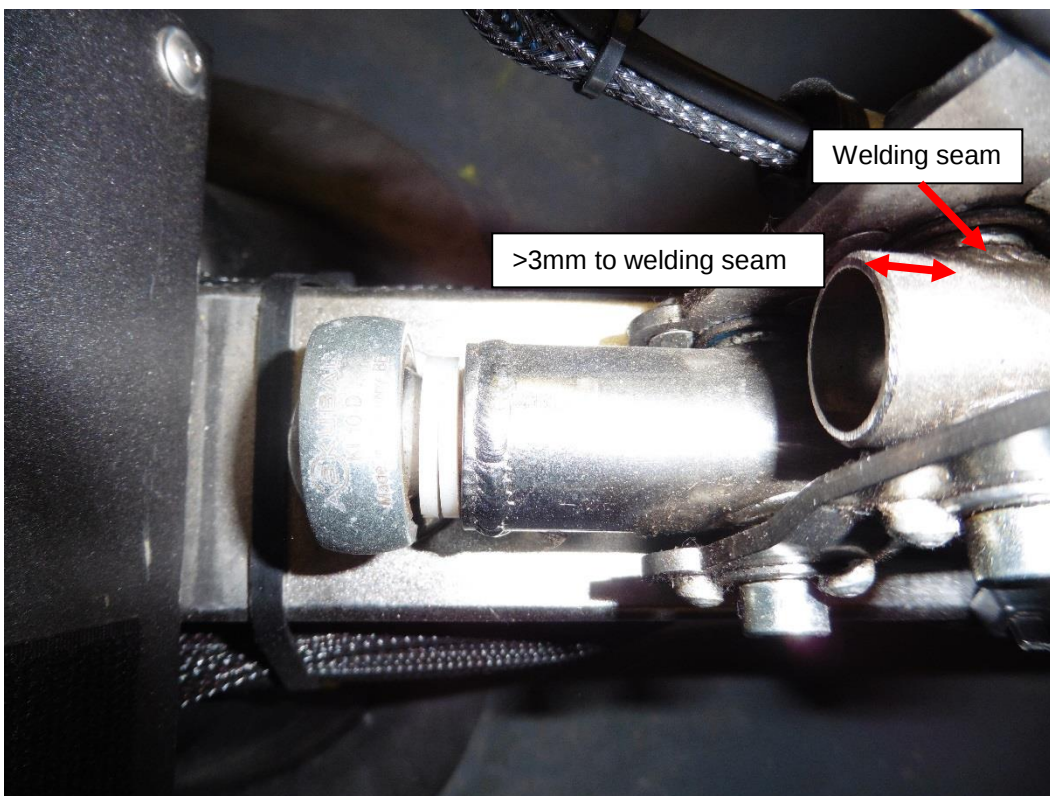
**Fig. 2: new control rod without cut**

Additionally, the check provides an opportunity to replace the existing tube with a later generation improved part should the original fall outside of the recommended dimensions.
