## Service Information Letter

| <b>Title: Software Upgrade digital ASI and ALTI</b> | | |
| <b>AG-SIL-2018-01-B-EN</b> | | <b>Compliance Category:</b> |
| <b>Aircraft type &amp; model:</b><br>Any AutoGyro type, fitted with digital ASI (Software Version 2.16 and older) and ALTI (Software Version 2.12 and older) | <b>Betroffene Werknummern:</b><br>Any AutoGyro type, fitted with digital ASI (Software Version 2.16 and older) and ALTI (Software Version 2.12 and older) | |

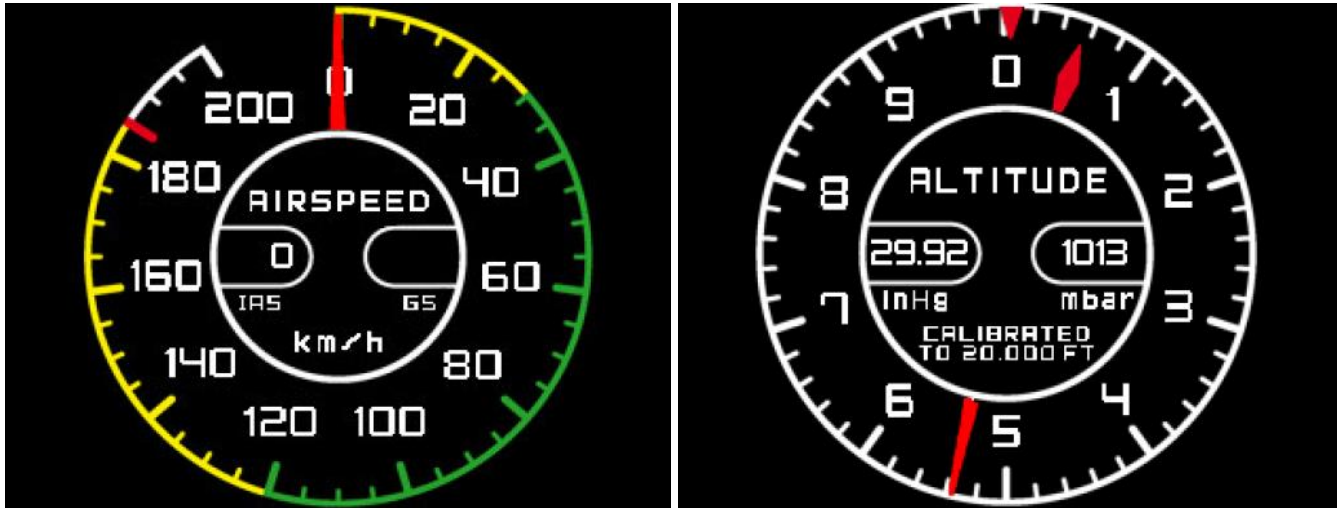
**Original instrument display**

AutoGyro has listened to market feedback regarding the visual appearance of instrument displays, and of the device reliability. The company decided to offer an upgrade to owners that makes the devices easier to read in different lighting conditions, and improves the operational reliability. Any device with a display as shown below may be upgraded to software level 2.17.
