| <b>Title: Cavalon window strength improvement</b> | | |
| <b>AG-SB-2022-08-C-EN</b> | <b>Effective Date: 26.09.2022</b> | <b>Compliance Category:</b> |
| <b>Aircraft type &amp; model:</b><br><br><b>AutoGyro Cavalon</b> | <b>Affected Serial number(s):</b><br><br><b>Up to SN V00533</b> | |

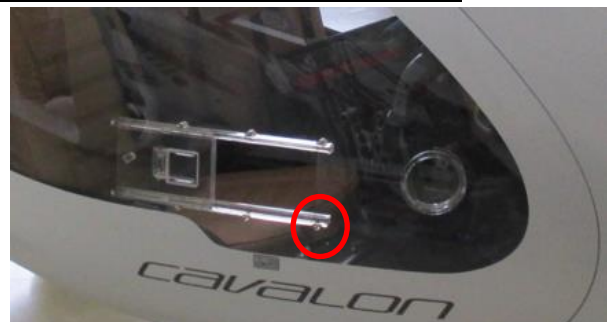
Due to improper opening and closing of the door via the ventilation window, cracks occasionally occur at the front lower corners of the ventilation windows at the screw connection.

- Uninstall the lower front screw
- Clean the outside surface of the cabin door with active glass cleaner (PN 30494)
