<b>Title: Coolant level indicator interpretation</b>		
<b>AG-SIL-2018-03-A-EN</b>		<b>Compliance Category:</b>
<b>Applicability</b>		<b>A - MANDATORY</b> <b>B – RECOMMENDED</b> <b>C – OPTIONAL</b>
<b>Aircraft type &amp; model:</b> MTOSport 2010 (where fitted) and 2017	<b>Affected aircraft serial numbers:</b> Any MTOSport fitted with an aluminium coolant tank with integral viewing window	
The maintenance manual to be referenced is this stated or subsequent issue.		As per AutoGyro website
<p>This form is the response from AutoGyro GmbH either against a problem found in the product in service requiring a containment or rectification action, or as service information for aircraft modification incorporation. For help, contact AutoGyro on 49(0)5121 88056-00, or email <a href="mailto:airworthiness@auto-gyro.com">airworthiness@auto-gyro.com</a>.</p>

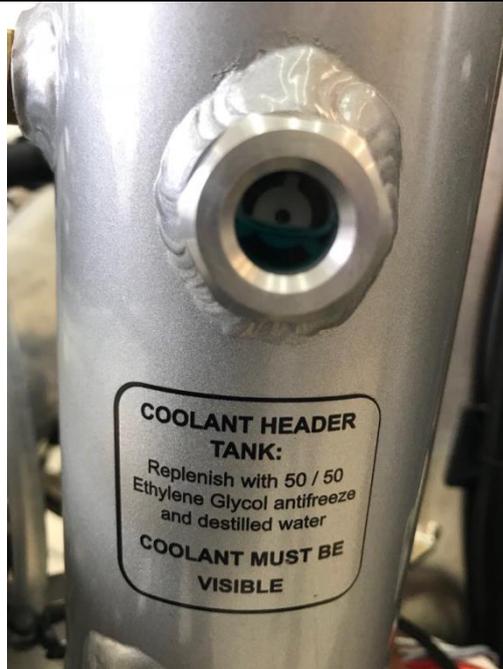
The integral viewing window built into the coolant header tank is designed to permit the inspecting person to determine that adequate coolant is present in the coolant tank before aircraft operation. During aircraft assembly it was found that sometimes the coolant hangs in a meniscus in the viewing window. This may lead the inspector to believe that adequate coolant is present, when the actual coolant level is low.

If the window is clear, or there is a meniscus of coolant showing in the window as in the photo, then the coolant level is considered low and must be topped up.

*Photo of viewing window, with meniscus of coolant showing.*

Coolant must be topped up with the correct 50/50 mix of ethylene glycol and distilled water. Recheck the level after topping up, and remember to replace the coolant header tank cap.
