Title: Cavalon 915iS Lower Engine Mounting Nuts		
AG-SB-2021-01-B-EN	Effective Date: 20 April 2021	Compliance Category: A – MANDATORY B – RECOMMENDED C – OPTIONAL
Applicability		
Aircraft type & model: AutoGyro Cavalon	Affected Serial number(s): AutoGyro Cavalon fitted with a Rotax 915iS engine	
The maintenance manual to be referenced is this stated or subsequent issue.		As per AutoGyro website
<p>This form is the response from AutoGyro GmbH either against a problem found in the product in service requiring a containment or rectification action, or as service information for aircraft modification incorporation. For help, contact AutoGyro on 49(0)5121 88056-00, or email airworthiness@auto-gyro.com.</p>

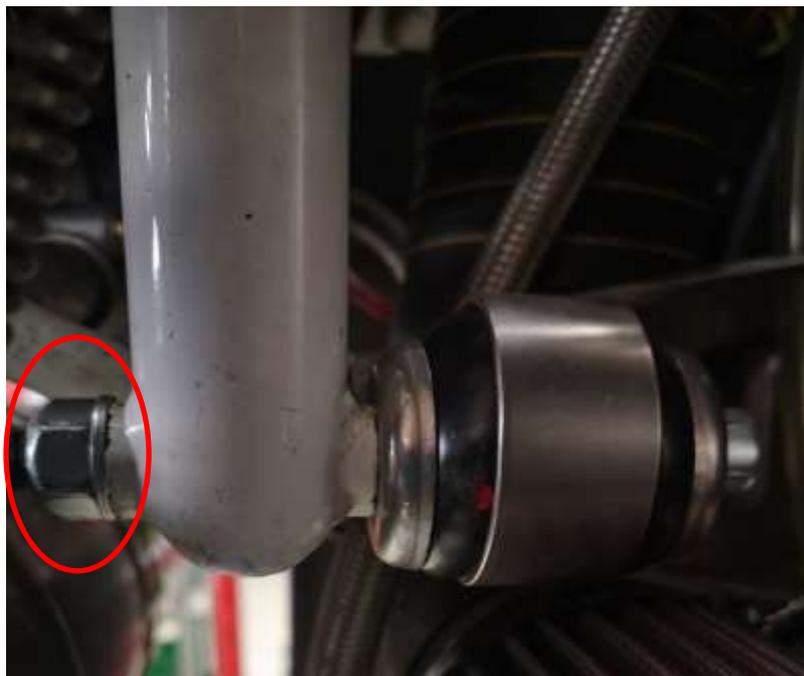
Engine mount assembly with SI full metal M10 nut

This service bulletin provides instructions for the replacement of the Binx M10 nuts (43511) or SI Nyloc M10 nuts (20183) with M10 SI full metal nuts (23630) for zinc plated engine mounting bolts.

1. Gain access to the engine mountings by removing the upper and lower engine cowlings in accordance with the AMM job card 52-00-00 4-1.
2. Determine whether Binx M10 nuts (43511) or SI Nyloc M10 nuts (20183) are assembled on any of the lower engine mounting bolts. If SI full metal M10 nuts are fitted, no further action is required.
3. If Binx M10 or SI Nyloc M10 nuts are fitted, then replace with M10 SI full metal nuts (23630) for zinc plated engine mounting bolts in accordance with Job Card 71-20-00 8-1 of the respective AMM. Tighten well, noting that it is extremely difficult to access with a torque wrench. Target tightening torque 39Nm. Ensure a minimum of 1.5 threads of the bolt end are protruding from the nut once torqued.
4. Carry out a loose article and tool check.
5. Refit any previously removed cowlings in accordance with the respective job card.
