Title: Pneumatic Clutch III (2017) – Pressure Disc Inspection		
AG-SB-2018-05-B-EN		Compliance Category:
Applicability		A – MANDATORY B – RECOMMENDED C – OPTIONAL
Aircraft type & model: All MTO2017 and all Calidus/Cavalon with rotor head III fitted	Affected Serial number(s): All MTO2017 and all Calidus/Cavalon with rotor head III fitted	
The maintenance manual to be referenced is this stated or subsequent issue.		As per AutoGyro website
This form is the response from AutoGyro GmbH either against a problem found in the product in service requiring a containment or rectification action, or as service information for aircraft modification incorporation. For help, contact AutoGyro on 49(0)5121 88056-00, or email airworthiness@auto-gyro.com .

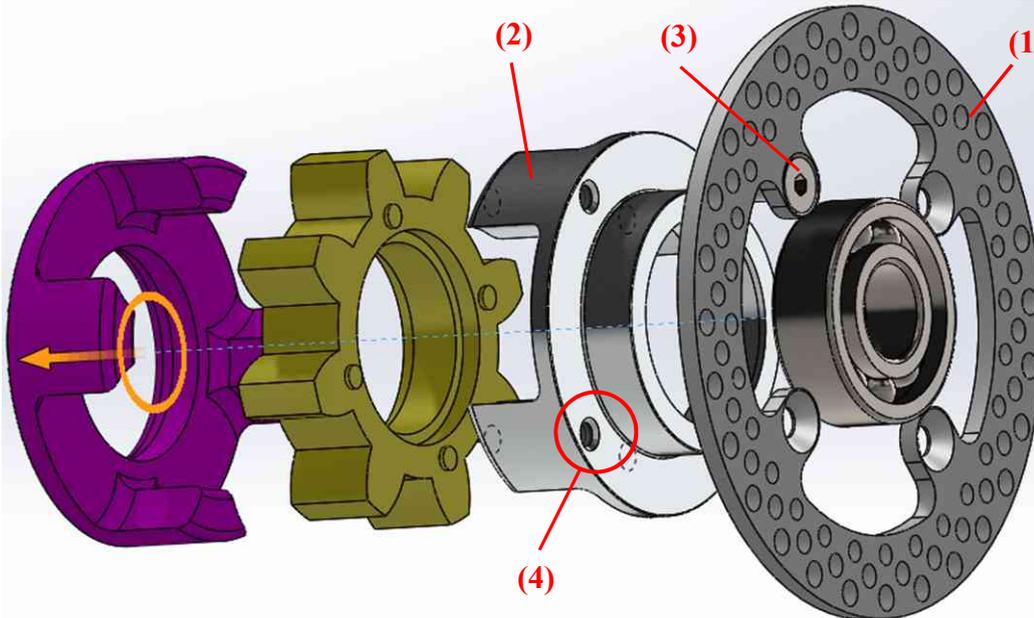
Fig. 1 - Pressure Plate Assembly (31713)

It has been found that the threaded holes in the first batch of pneumatic clutch III (2017) Pressure Plate front (2) are not sufficiently countersunk to accept the countersunk screws securing the Pressure Disc PKII (1). The effect is that the screws are unable to properly clamp the disc and plate together, possibly leading to looseness, rattle noise, and wear of this connection.

1. Remove any cowlings required to gain access to the clutch assembly.
2. Remove the pneumatic clutch from the engine in accordance with AMM job card 63-11-10 4-1.
3. Remove the center screw retaining the pressure plate assembly (31713) to the clutch in accordance with AMM job card 63-11-10 8-1 part 4.
4. Remove the pressure plate assembly (31713) from the clutch and remove the 4 countersunk screws (3) securing the pressure disc (1) to the pressure plate front (2).
5. Inspect for signs of rotational movement of the pressure disc (1) on the pressure plate front (2), and/or elongated holes in the disc (1). If damaged, replace (article 23604).
6. Inspect the complete clutch assembly for any further damage and replace any affected parts (eg. 31713 Pressure Plate Mounted).
7. Inspect the pressure plate front (2) and ensure that the threaded holes (4) are countersunk to a

- depth of 1mm with a 45° countersink. If not, re-work with a suitable countersink tool.
8. Re-assemble the clutch in reverse order of disassembly.
 9. Assemble the clutch to the engine in accordance with AMM job card 63-11-10 4-1.
 10. Re-fit any cowlings previously removed.
 11. Ground run the aircraft in a suitably secured area, including a pre-rotation clutch functional check.
 12. Note the SB action within the aircraft documentation.
