Title: Rotorhead III Teeter Stop Assembly Screws		Compliance Category: A – MANDATORY B – RECOMMENDED C – OPTIONAL
AG-SB-2020-01-B-EN		
Applicability		
Aircraft type & model: AutoGyro Cavalon & MTO 2017 as listed	Affected Serial number(s): V00418 – V00424, RSUK-V00426, RSUK-V00428, V00430-432, RSUK- V00433, V00434, RSUK-V00449 and RSUK-V00450 M01762, M01763, M01873	
The maintenance manual to be referenced is this stated or subsequent issue.		As per AutoGyro website
This form is the response from AutoGyro GmbH either against a problem found in the product in service requiring a containment or rectification action, or as service information for aircraft modification incorporation. For help, contact AutoGyro on 49(0)5121 88056-00, or email airworthiness@auto-gyro.com .

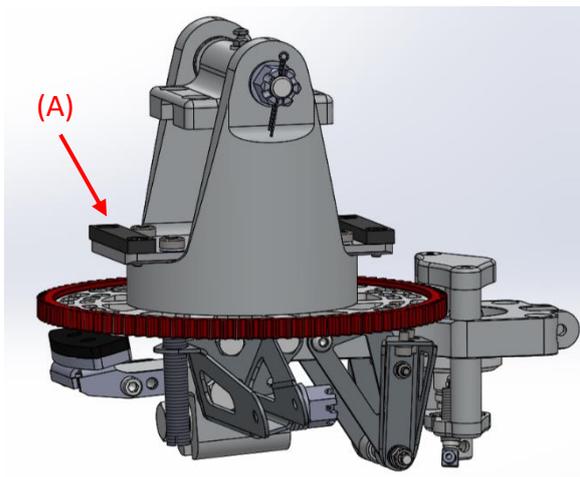
(Pic.1)

It has been found that the Loctite securing the four M5x14 screws that retain the teeter stop (23794) to the mounting plate assembly (31800) may have been omitted (on a rotor head III).

1. Ensure the aircraft has pressure in the rotor brake system and the rotor brake and wheel brakes are applied.
2. Either remove the rotor system, or remove the rotor bag and teeter the rotor system sufficiently to gain access to the teeter stop assembly (31800) (Pic. 1 (A)).
3. Remove one of the countersunk M5x14 screws from one of the teeter stops (23794) on the teeter stop plate assembly (31800) and inspect for Loctite residue on the threads (Pic. 2 (B)).
4. If Loctite residue is visible, clean the threads, re-apply Loctite 243 (21344) or local equivalent to the thread and re-fit the screw hand-tight, ensuring no deformation of the teeter stop.
5. If no Loctite residue is visible, apply Loctite 243 (21344) or local equivalent to the thread and re-fit the screw hand-tight, ensuring no deformation of the teeter stop. Carry out the same process to the other 3 screws.
