Title: MTO2017 915iS Intercooler Mounting Assembly	
AG-SB-2020-03-B-EN	
Applicability	
Aircraft type & model: AutoGyro MTO2017	Affected Serial number(s): All MTO2017 fitted with the Rotax 915iS engine
The maintenance manual to be referenced is this stated or subsequent issue.	
As per AutoGyro website	
<p>This form is the response from AutoGyro GmbH either against a problem found in the product in service requiring a containment or rectification action, or as service information for aircraft modification incorporation. For help, contact AutoGyro on 49(0)5121 88056-00, or email airworthiness@auto-gyro.com.</p>

Reason and overview of the Service Bulletin (cause of problem if known)

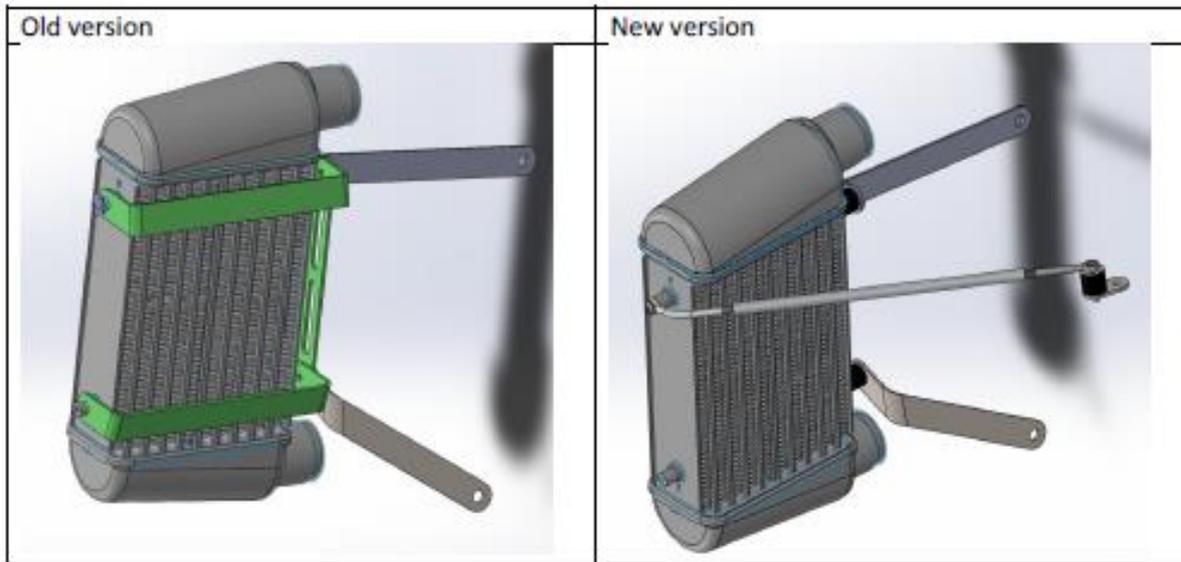
(Pic. 3)

AutoGyro has received feedback from the market that the current 915iS intercooler attachment brackets may, in some cases lead to breakage of the intercooler attachment lugs.

6. Remove the intercooler support frame (Pic. 3 – old version, green items)
7. Ensure the engine is supported and remove the upper and lower engine mounting bolts in accordance with AMM Job Card 71-20-00 8-1.
