<b>Title: Pneumatic Clutch III &amp; IV – Plate Wear Limits</b>	
<b>AG-SIL-2021-02-EN</b>	<b>Effective Date:</b> 10 May 2021
<b>Applicability</b>	
<b>Aircraft type &amp; model:</b>  Calidus, Cavalon & MTO2017	<b>Affected Serial number(s):</b>  All models fitted with a pneumatic clutch incorporating a clutch plate without wear indication slots
The maintenance manual to be referenced is this stated or subsequent issue.	As per AutoGyro website
<p>This form is the response from AutoGyro GmbH either against a problem found in the product in service requiring a containment or rectification action, or as service information for aircraft modification incorporation. For help, contact AutoGyro on 49(0)5121 88056-00, or email <a href="mailto:airworthiness@auto-gyro.com">airworthiness@auto-gyro.com</a>.</p>

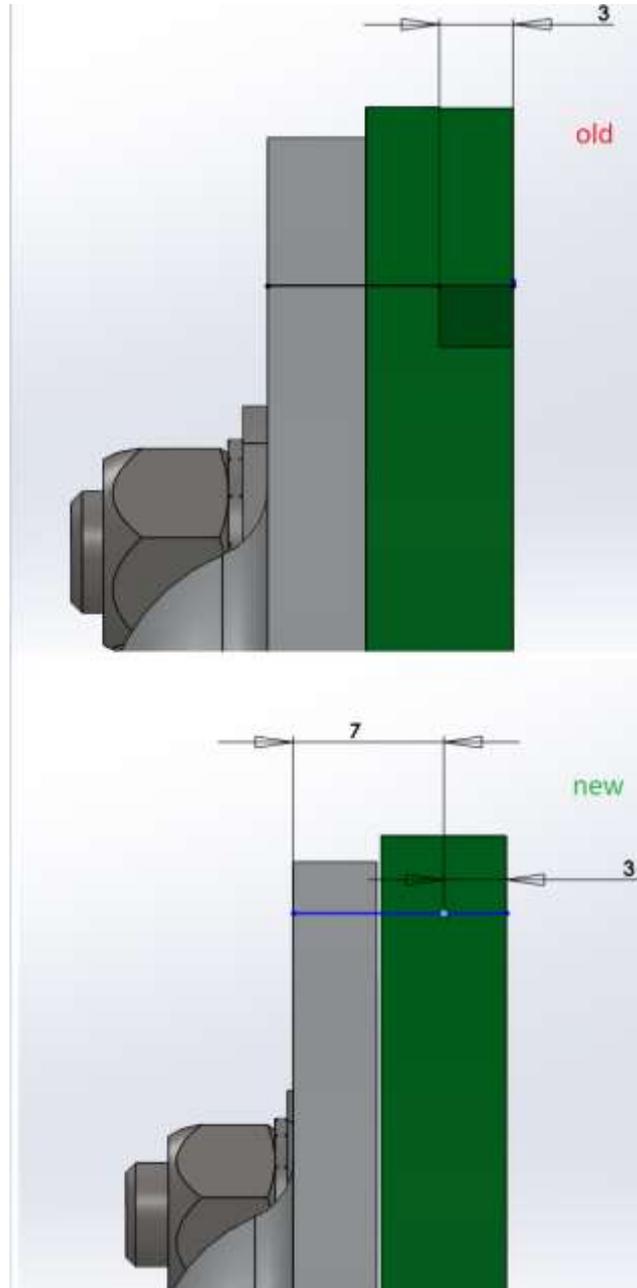
The new series of pneumatic clutch installed in AutoGyro Calidus, Cavalon and MTO2017 models, as well as the spare part replacement plate set (46137) are now produced and assembled without wear-limit grooves in the clutch pad.

The current inspection method for clutch plate wear stated in job card 63-11-10 6-1 of the respective maintenance manual is therefore no longer valid for clutches incorporating this type of plate. This SIL is the overriding authority in these cases.

The minimum thickness of pad and backing plate as per the diagram below is 7mm, regardless of the presence of wear limit grooves.

**Changes to the indication limits must be recorded within the aircraft documentation, in line with the requirements of the country of operation.**
