Title: Ivoprop motor controller software update		
AG-SB-2018-07-B-EN		Compliance Category:
Applicability		A – MANDATORY B – RECOMMENDED C – OPTIONAL
Aircraft type & model: Any AutoGyro gyroplane fitted with an Ivoprop propeller.	Affected Serial number(s): Any AutoGyro gyroplane fitted with an Ivoprop propeller.	
The maintenance manual to be referenced is this stated or subsequent issue.		As per AutoGyro website
This form is the response from AutoGyro GmbH either against a problem found in the product in service requiring a containment or rectification action, or as service information for aircraft modification incorporation. For help, contact AutoGyro on 49(0)5121 88056-00, or email airworthiness@auto-gyro.com .

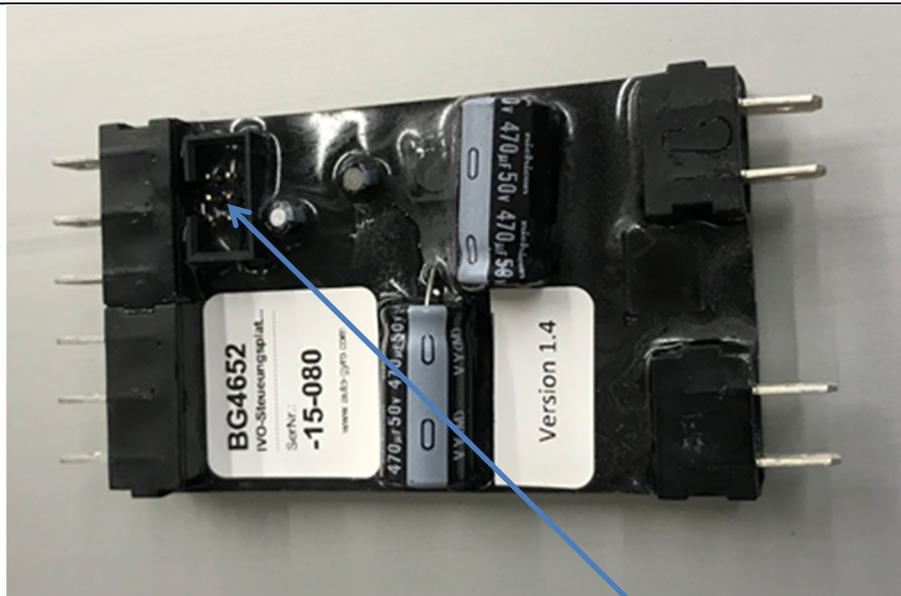
Photo of the Control Board. Connector

1. Locate the Control Board module (see photo), which is either located on the left side of the forward seat (MTO Sport) or behind the instrument panel. On some aircraft this may be easily accessible without removing the panel, on others the panel must be detached from the aircraft and pulled rearwards to give access.
2. Disconnect the supply cables to the control board.
3. The Control Board will be secured either by Velcro or zip ties, or possibly adhesive. Remove the Control Board.
4. Fit the new Control Board, secure, and reconnect the cables.
5. Refit the panel if detached and check all fastenings secure.
6. In a safe area, turn on the aircraft keyswitch to power the aircraft systems.
7. Operate the propeller pitch change switch from full fine to full coarse and back to full fine 5 times. Ensure the function is normal.
8. Complete the aircraft logbook entries as market applicable.
