<b>Title: IVO-prop gearbox overhaul</b>		
<b>AG-SB-2017-05-B-EN</b>		<b>Compliance Category:</b>
<b>Applicability</b>		<b>A - MANDATORY</b>
<b>Aircraft type &amp; model:</b> Any AutoGyro type fitted with IVO-prop DL3-68 VP-propeller	<b>Aircraft serial Nos. affected:</b> Any AutoGyro type fitted with IVO-prop DL3-68 VP-propeller	<b>B - RECOMMENDED</b>
The maintenance manual to be referenced is this stated or subsequent issue.		<b>C - OPTIONAL</b>
The maintenance manual to be referenced is this stated or subsequent issue. As per AutoGyro website		
This form is the response from AutoGyro GmbH either against a problem found in the product in service requiring a containment or rectification action, or as service information for aircraft modification incorporation. For help, contact AutoGyro on 49(0)5121 88056-00, or email <a href="mailto:airworthiness@auto-gyro.com">airworthiness@auto-gyro.com</a> .

**Reason and overview of the Service Bulletin (cause of problem if known)**

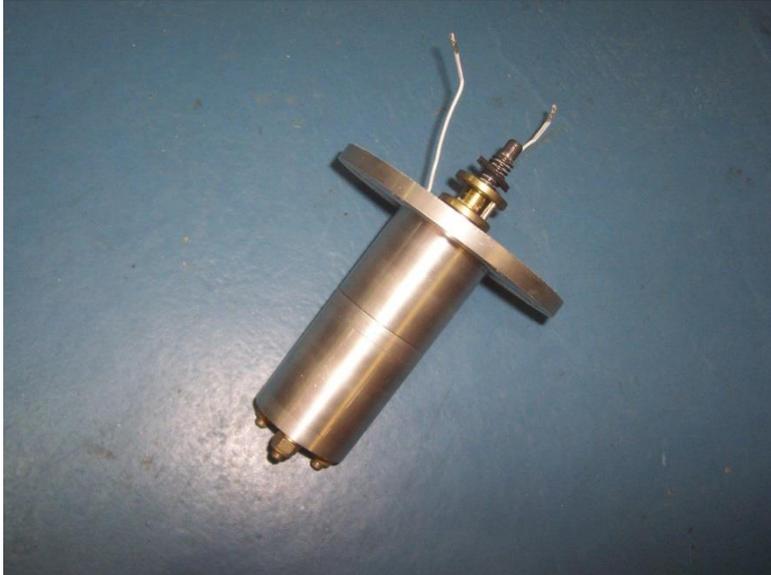
Motor/gearbox assembly removed
