Title: Calidus 914 Engine Air Filter - Optional Position For Hot Countries		
AG-SB-2020-06-C-EN		Compliance Category: A – MANDATORY B – RECOMMENDED C - OPTIONAL
Applicability		
Aircraft type & model: AutoGyro Calidus	Affected Serial number(s): Calidus fitted with the Rotax 914 engine operating in hot countries	
The maintenance manual to be referenced is this stated or subsequent issue.		As per AutoGyro website
This form is the response from AutoGyro GmbH either against a problem found in the product in service requiring a containment or rectification action, or as service information for aircraft modification incorporation. For help, contact AutoGyro on 49(0)5121 88056-00, or email airworthiness@auto-gyro.com .

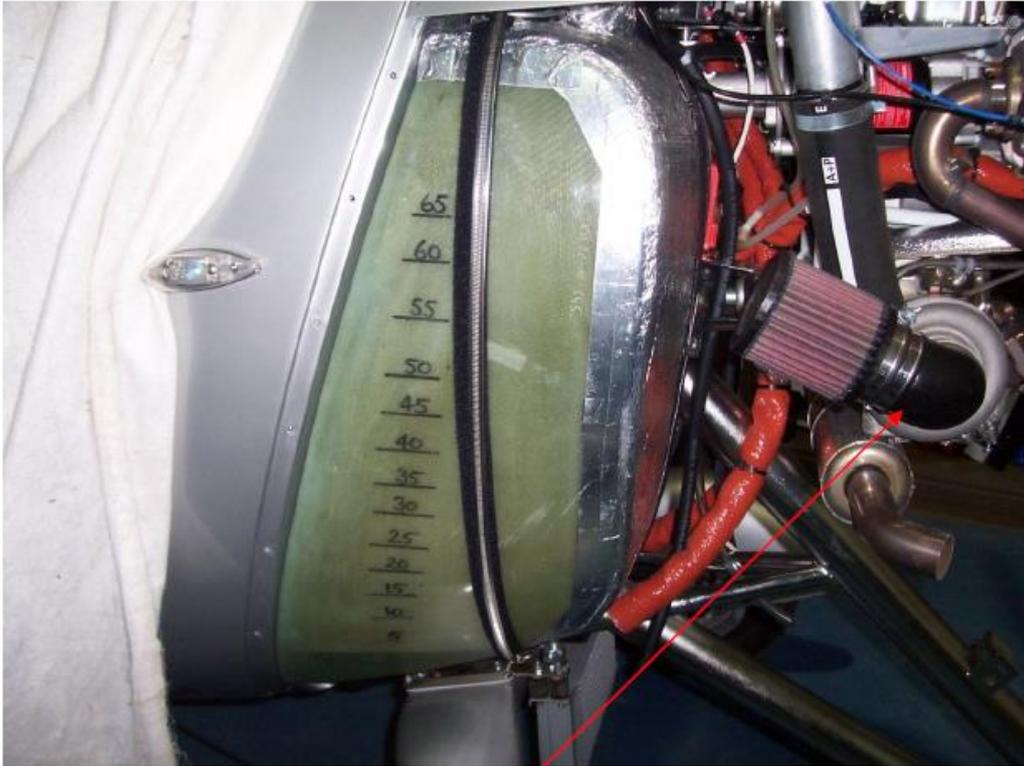
For Calidus aircraft fitted with the 914UL turbo-charged engine, when operating in hot ambient conditions or using a high power setting for long periods of slow flight, it has been found that the Rotax turbo-control unit (TCU) detects over-temperature of the compressed air and restricts the power output. This is exacerbated by the location of the air inlet inside the engine cowling, so repositioning this outside the cowling will provide cooler incoming air. This is achieved by means of an extension tube and aperture cut into the engine cowling just above the exhaust aperture. The tube is attached to the turbo inlet by means of a pipe clip, the same method as the original filter attachment. The new aperture does not significantly affect the strength of the cowling and no reinforcement is required. The whole installation is protected against detachment by means of a 1.5mm safety wire.

Intake before modification

1. Remove the upper engine cowling and lower left engine cowling as described in the AMM Job Card 52-00-00 4-1.
2. Remove the existing air filter installation (Pic. 1) and cover the turbo inlet with a film of "gaffer" tape.

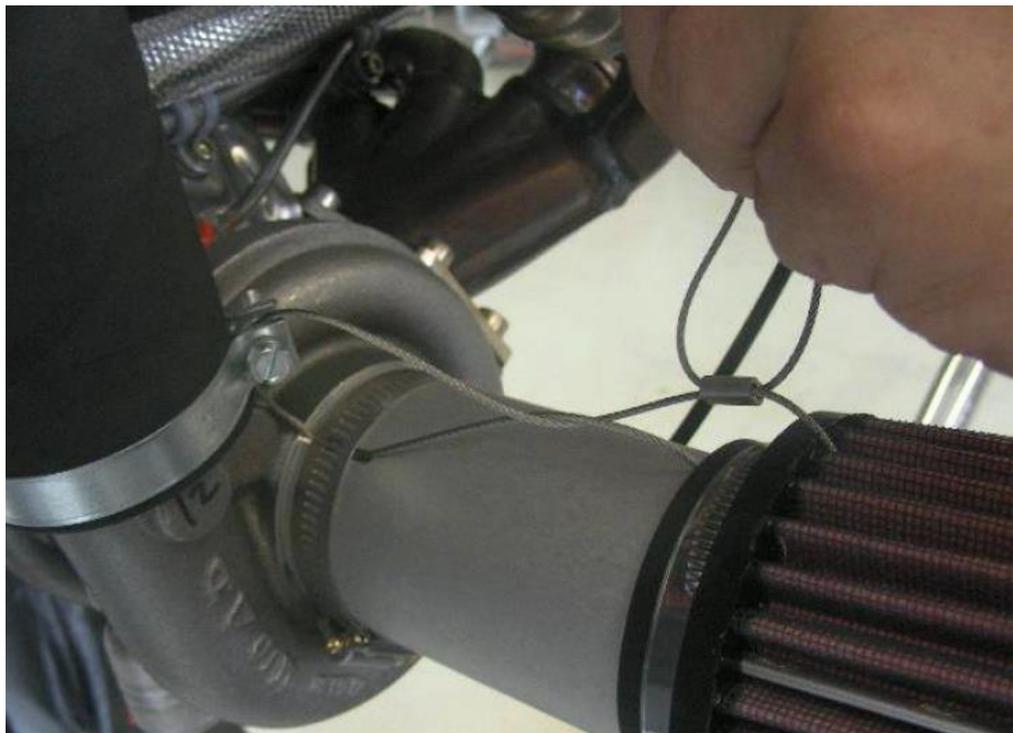
(Pic. 4)

Intake after modification
