Title: Frame inspection		
AG-SIL-2022-1-EN		Released:
Applicability		15 th August 2022
Aircraft type & model: MTOsport 2017	Affected Serial number(s): All MTOsport 2017	
The maintenance manual to be referenced is this stated or subsequent issue.		As per AutoGyro website
This form is the response from AutoGyro GmbH either against a problem found in the product in service requiring a containment or rectification action, or as service information for aircraft modification incorporation. For help, contact AutoGyro, email: airworthiness@auto-gyro.com .

Reason and overview of the Service Information Letter

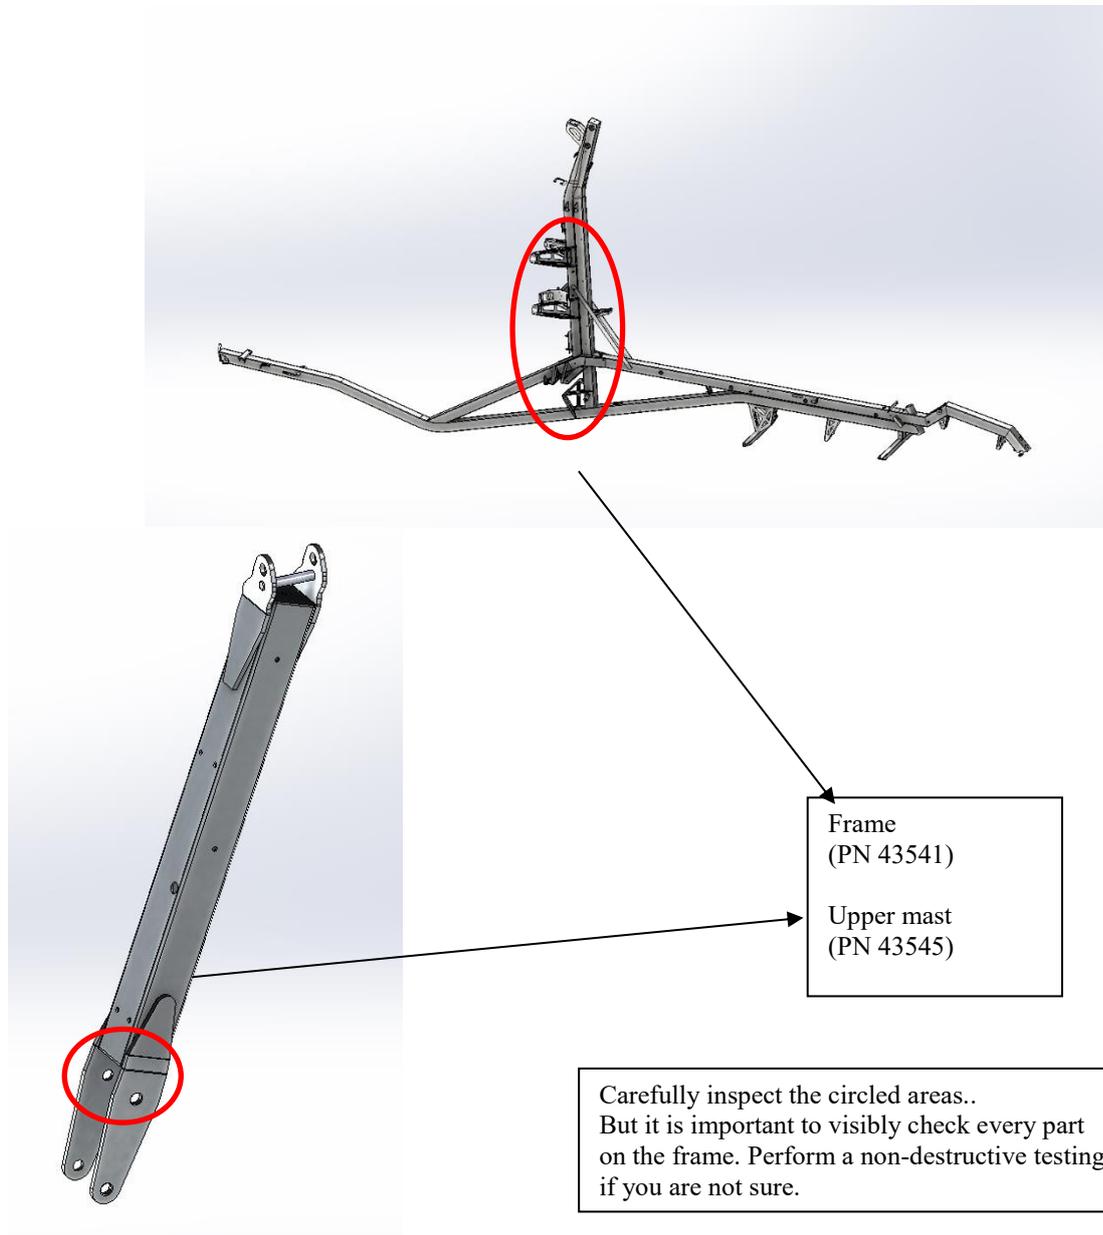
Possible damages can occur beneath the lower engine mount, on the bracket for the undercarriage and on the brackets of the upper mast (PN 43545) in case of the two piece frame.

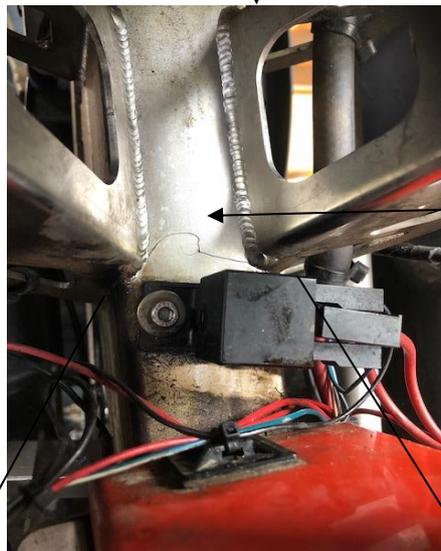
Crack between the engine mount LH and RH

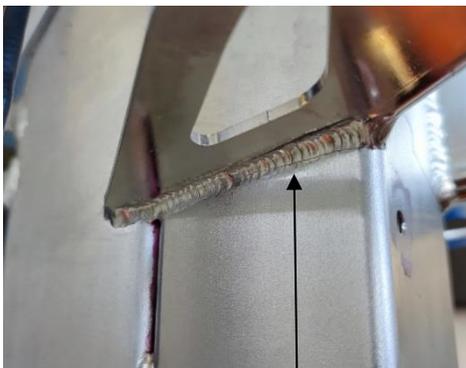
Crack on the underside L/H

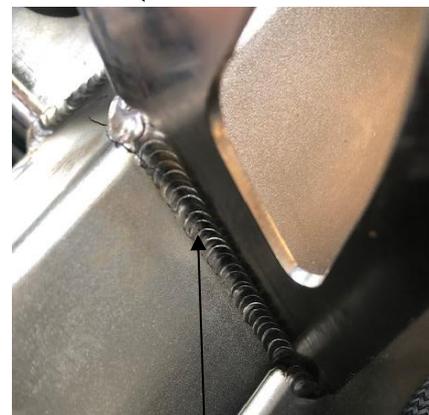
Crack on the underside R/H
