| <b>Title: Cavalon 915iS Oil Tank To Fuel Pump Clearance</b> | | |
| <b>AG-SB-2021-02-B-EN</b> | <b>Effective Date:</b> 12 May 2021 | <b>Compliance Category:</b><br><br><del>A – MANDATORY</del><br><b>B – RECOMMENDED</b><br><del>C – OPTIONAL</del> |
| <b>Aircraft type &amp; model:</b><br><br>AutoGyro Cavalon | <b>Affected Serial number(s):</b><br><br>AutoGyro Cavalon fitted with a Rotax 915iS engine | |

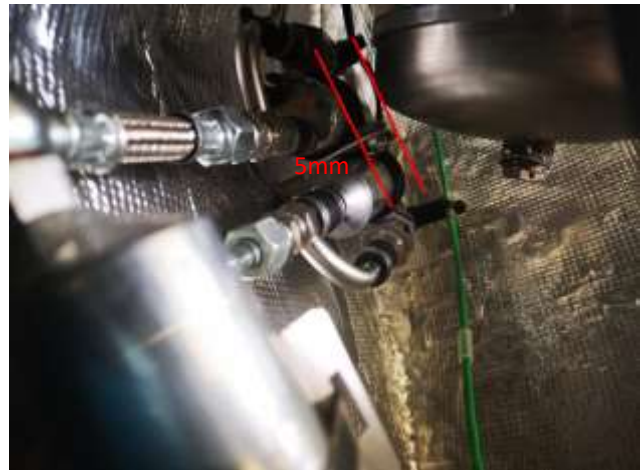
(Pic. 2)

There is a possibility that a small number of factory built Cavalon 915iS gyros may have entered the market with an incorrectly positioned Rotax oil tank. This could potentially lead to the lower forward radius of the tank contacting the fuel pump assembly.

3. There must also be a minimum of 5mm clearance between the lower forward edge of the oil tank and the pump assembly (Pic. 2).
4. The distance between the upper clamp and the lower face of the oil tank lid clamp should be approximately 6cm (Pic. 3).

- c. Re-tighten the 2 oil tank securing clamps (Pic. 3 items A & B).
  - d. Check the clearances stated in steps 2 and 3. If these clearances are not met, adjust the tank position until they are.

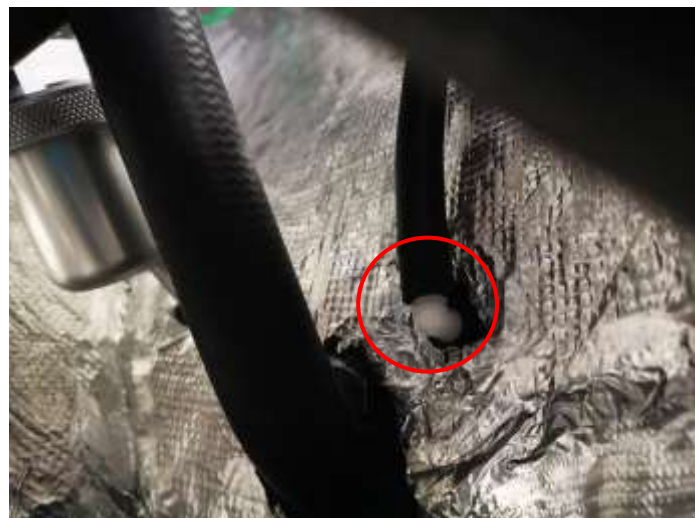
(Pic. 4)

- e. Check sufficient clearance of the tank to all other surrounding assemblies.
  - f. If the breather hose was removed in step 6.b. and is now too short, remove the lower end of the hose from the 90° angle connector (Pic. 4), cut a new piece of hose (40282) to length and assemble to the 90° angle connector and oil tank breather take-off (silicone spray can be used to allow sliding of the hose through the P-clip securing the hose to the engine compartment). Re-secure the click clamp (Pic. 3 item C).

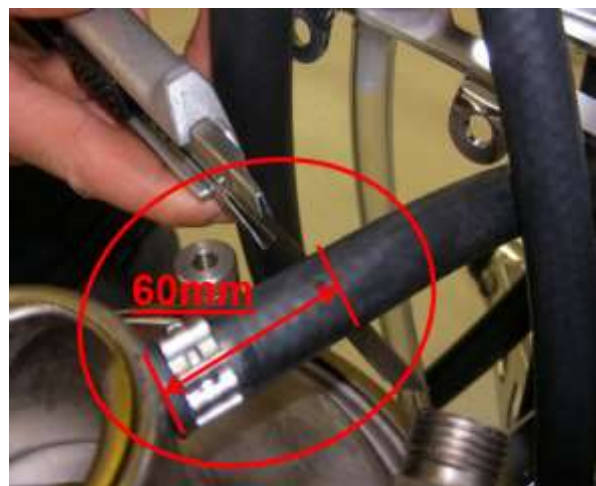
(Pic. 5)

- g. Using a suitable sharp bladed knife, cut a 2.5 to 3mm deep slot in the underside of the breather hose, 60mm from the end of the hose (Pic. 5). This slot is to allow the oil system to breathe, should the open end of the hose be iced up.
