| <b>Title: MTO2017 Oil Breather hose routing</b> | | |
| <b>AG-SB-2023-01-C-EN</b> | <b>Effective Date: 01.04.2023</b> | <b>Compliance Category:</b><br><br><b>A - MANDATORY</b><br><b>B - RECOMMENDED</b><br><b>C - OPTIONAL</b> |
| <b>Aircraft type &amp; model:</b><br><br><b>MTO2017</b> | <b>Affected Serial number(s):</b><br><br><b>All MTO2017 produced before 07/2021</b> | |

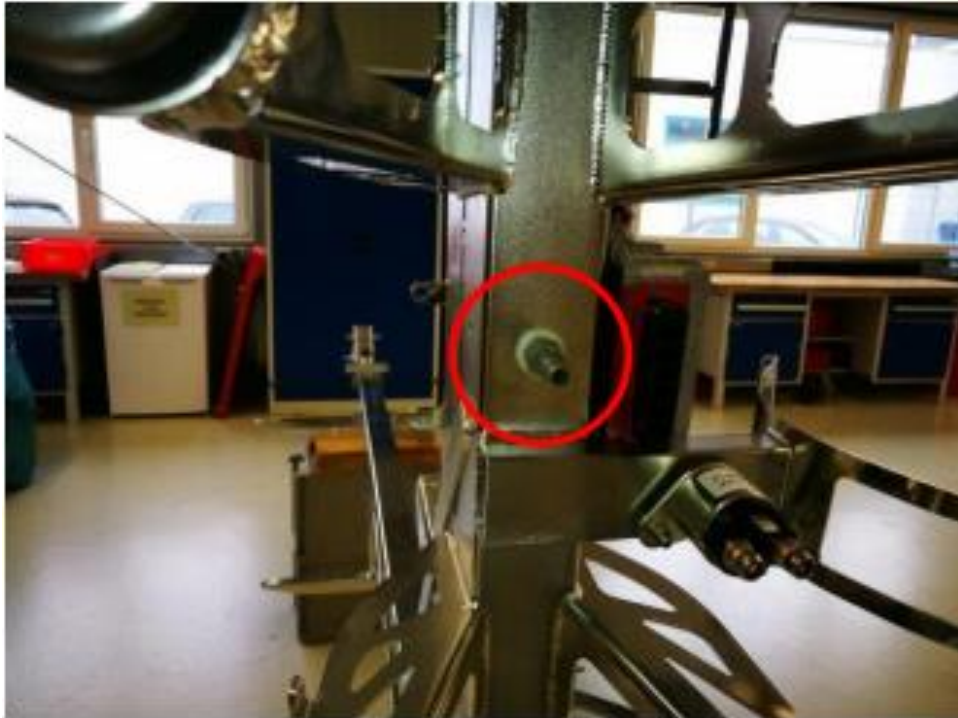
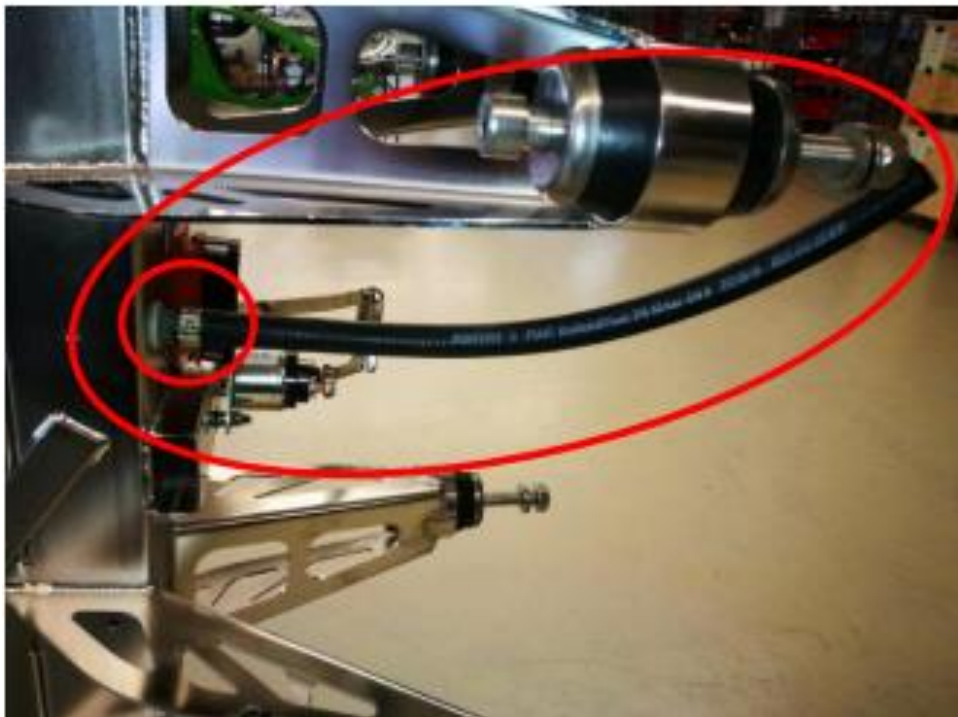
The oil breather hose is connected from the top of the oil tank into the stainless steel frame of the aircraft. The oil vapour of the engine should go overboard via the frame below the aircraft. Due to the fact that the frame has several openings in different places, it has been found in service that, in some circumstances, the oil vapour may be vented such that the occupants notice an oil smell.

Old version of oil breather hose routing:

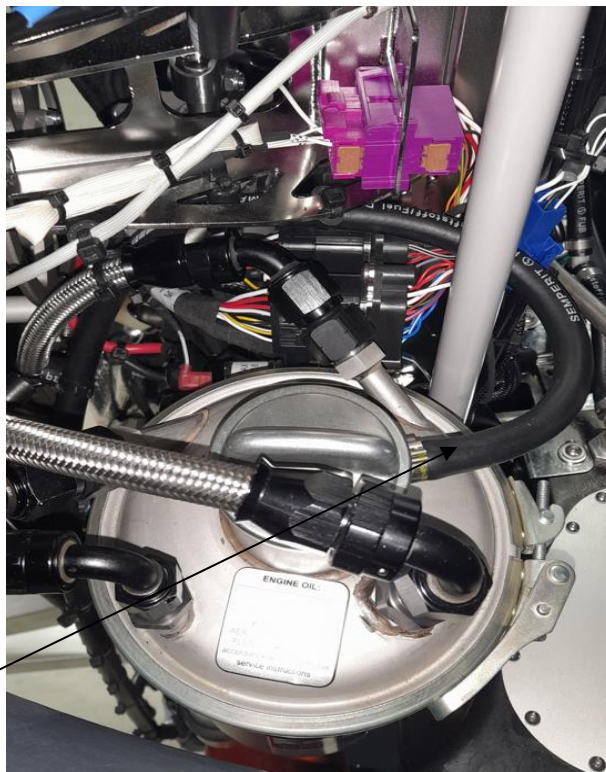
New routing of oil breather hose:

Breather hose

This situation has been improved by extending the oil vent hose such that it leads directly to the lower end of the airframe cell where the oil vapour is blown away beneath the aircraft.

Remove the old oil breather hose from the tank and the mast. Install the new oil breather hose on the oil tank and fix it as shown on the pictures below.

Ensure that there is a cut in the hose near the tank in the same position as the removed hose. This cut is to allow the engine to oil system to breath in the event that the moisture in the lower part of the breather tube freezes in flight.

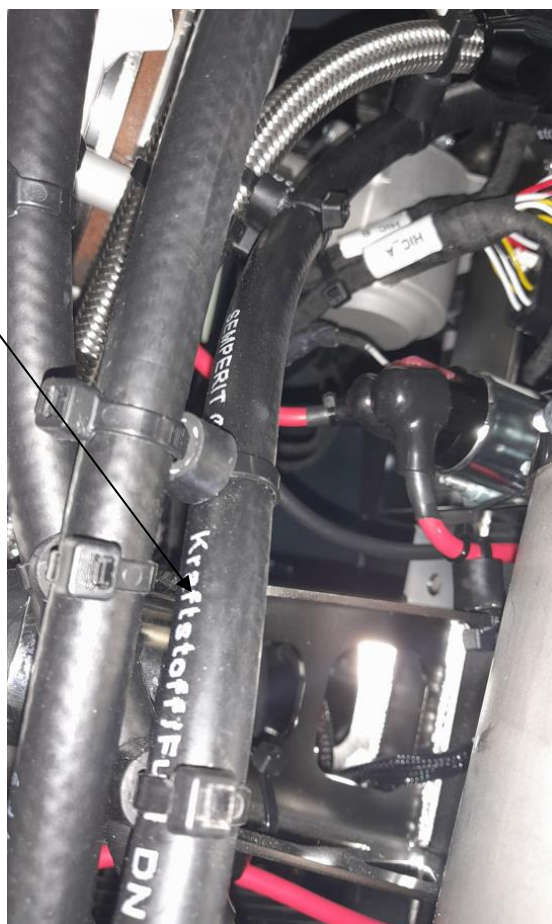
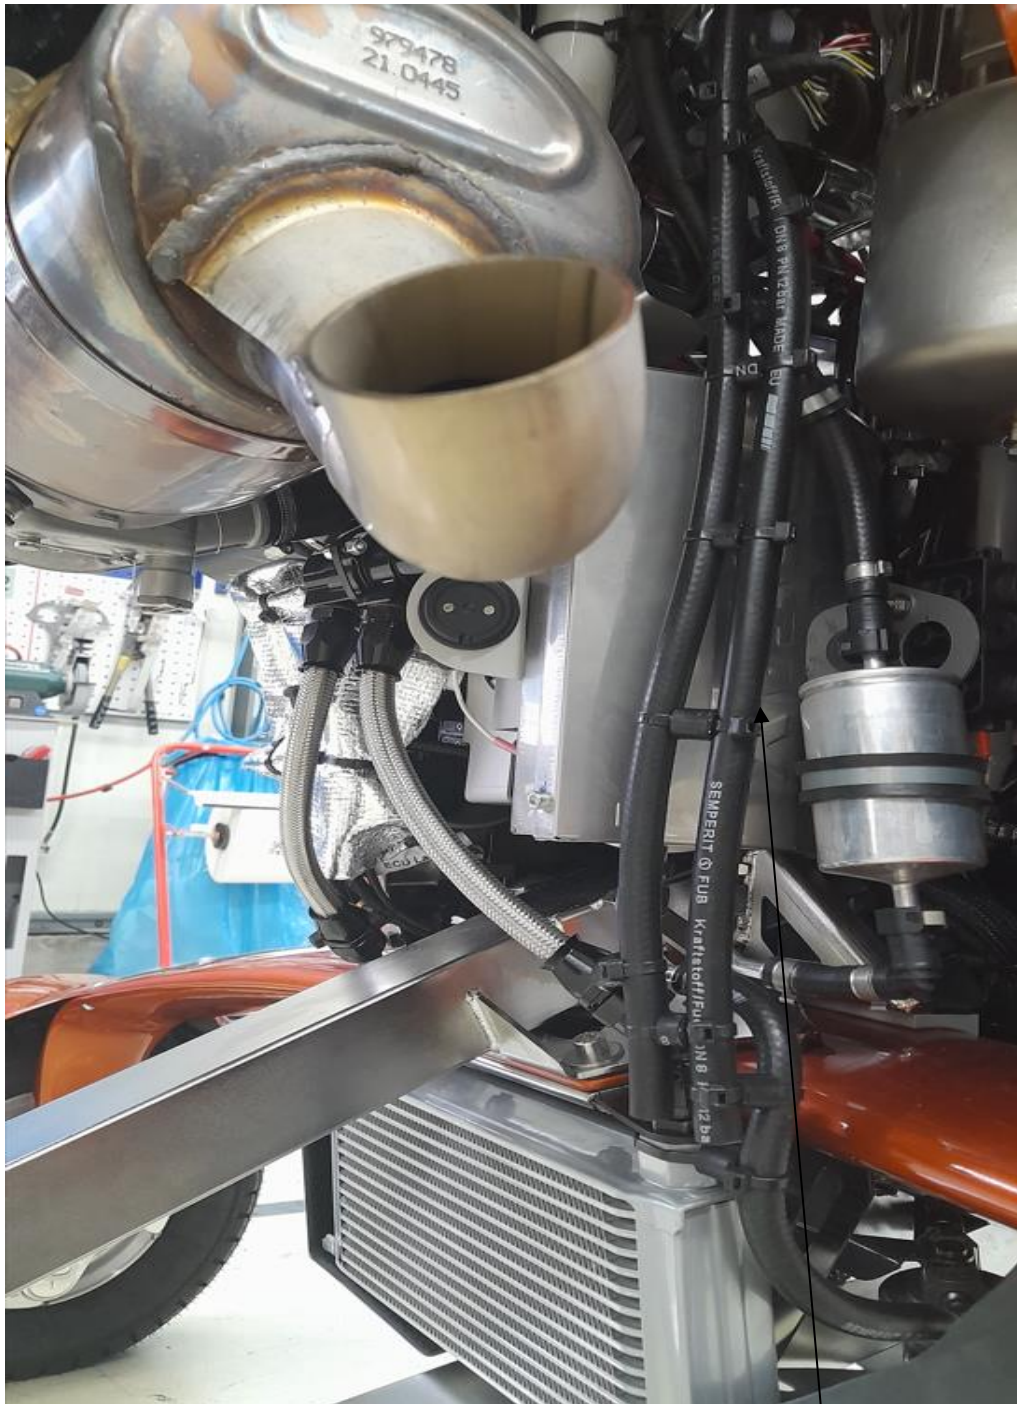
Breather hose
