Title: Cavalon (Rotorhead III) & MTO2017 Pitch Trim Pressure Correction		
AG-SB-2019-02-B-EN		Compliance Category:
Applicability		A – MANDATORY B – RECOMMENDED C – OPTIONAL
Aircraft type & model: Cavalon & MTO2017 with Rotorhead III	Affected Serial number(s): All Cavalon from V00349 & all MTO2017 (Rotorhead III)	
The maintenance manual to be referenced is this stated or subsequent issue.		As per AutoGyro website
<p>This form is the response from AutoGyro GmbH either against a problem found in the product in service requiring a containment or rectification action, or as service information for aircraft modification incorporation. For help, contact AutoGyro on 49(0)5121 88056-00, or email airworthiness@auto-gyro.com.</p>

Reason and overview of the Service Bulletin (cause of problem if known)

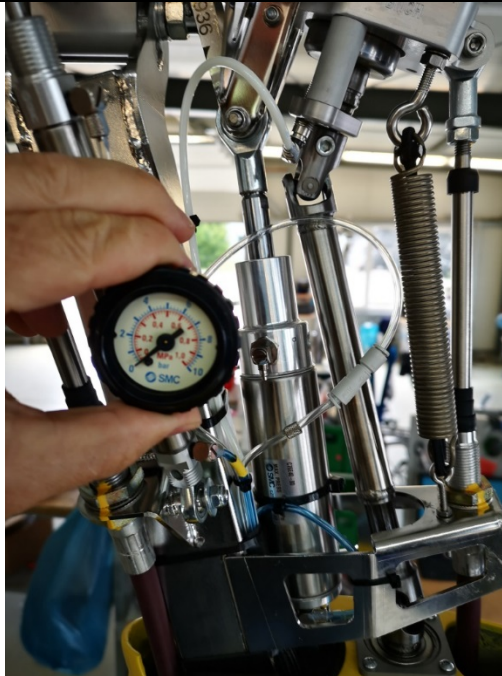
1. Remove the upper pneumatic connection (clear hose) of the brake/trim cylinder and attach a manometer with a non-return valve (Pic.1)
2. Unhook the rotor bag from the nose and ensure the rotor is able to pitch rearwards under control (a second person holding the bag chord).
3. Switch the flight/brake switch to flight, ensure the propeller is clear of obstruction and turn on the ignition.
4. Apply nose up trim by moving the 4-way switch on the top of the stick to the rear.
5. Note the maximum pressure reading on the manometer. If it is 8 bar then no further action is required. Reconnect the upper brake/trim cylinder pneumatic hose and mark with mechanic paint.
6. If the pressure is more than 0.25 bar less than that displayed in the cockpit then carry out steps 7-13:

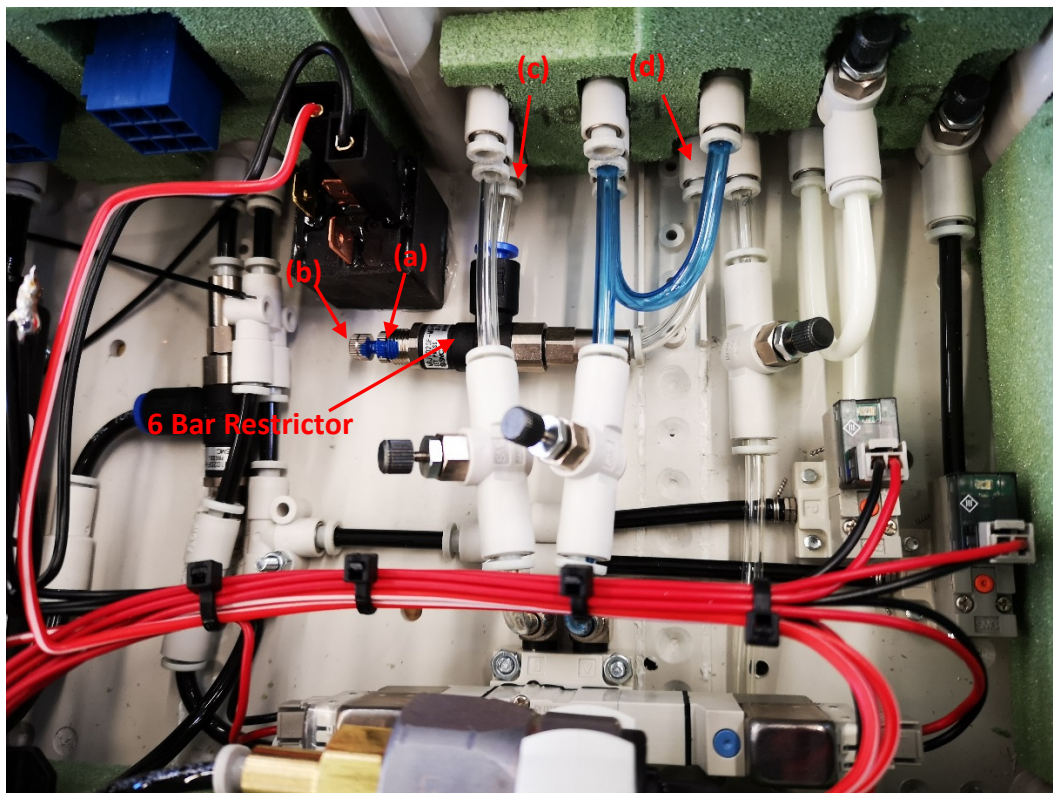
(Pic.2)

7. Gain access to the 6 bar pressure restrictor (pic.2) by removing the cover of the pneumatic box (in the nose area behind the cockpit of the Cavalon 915, behind the engine bay firewall in the Cavalon 914, or in the nose compartment of the MTO2017 – 6 screws).
WARNING: If the box has the heating option fitted then the elements are attached to the lid and must be disconnected from the box at the black 3 pin connector.

8. **Either:** release the lock-nut of the adjustment knob of the restrictor (a) and screw the adjustment knob (b) in until 8 bar is measured in steps 1-5 above. Re-lock the lock-nut and mark with mechanic paint.

9. **Or the preferred solution:** remove the restrictor and connecting hoses at points (c) and (d) (pic.2) and replace with a single piece of clear pneumatic hose of approx. 130mm length (pic.3).

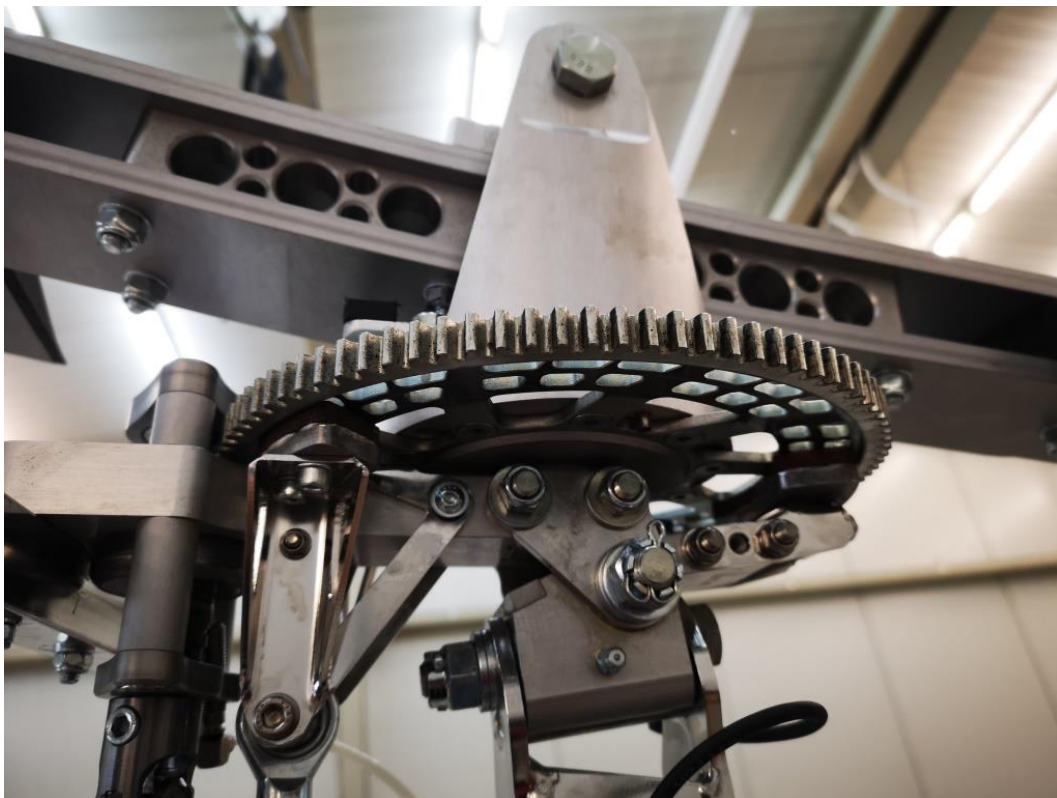
Aircraft fitted with Rotorhead III (see photos) have a shorter distance between the rotorhead pitch axis and trim cylinder attachment, such that a higher trim cylinder pressure results in the same hand force on the stick.
