<b>Title: Replacement of the brake piston O- ring</b>		
<b>AG-SB-2022-10-C-EN</b>	<b>Effective Date: 13.12.2022</b>	<b>Compliance Category:</b>  <b>A - MANDATORY</b> <b>B - RECOMMENDED</b> <b>C - OPTIONAL</b>
<b>Applicability</b>		
<b>Aircraft type &amp; model:</b>  <b>All types and models</b>	<b>Affected Serial number(s):</b>  <b>All AutoGyro aircrafts</b>	
The maintenance manual to be referenced is this stated or subsequent issue.		As per AutoGyro website
This form is the response from AutoGyro GmbH either against a problem found in the product in service requiring a containment or rectification action, or as service information for aircraft modification incorporation. For help, contact <a href="mailto:airworthiness@auto-gyro.com">airworthiness@auto-gyro.com</a> .

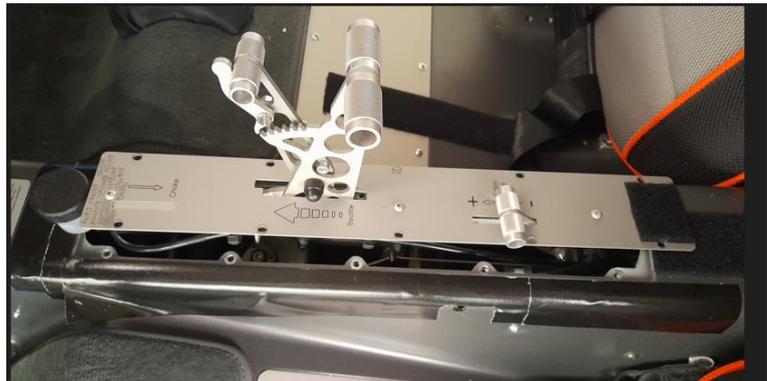
Cavalon:

Protect the surface around the center console.  
Remove the center console to fill up brake fluid after the replacement is done.

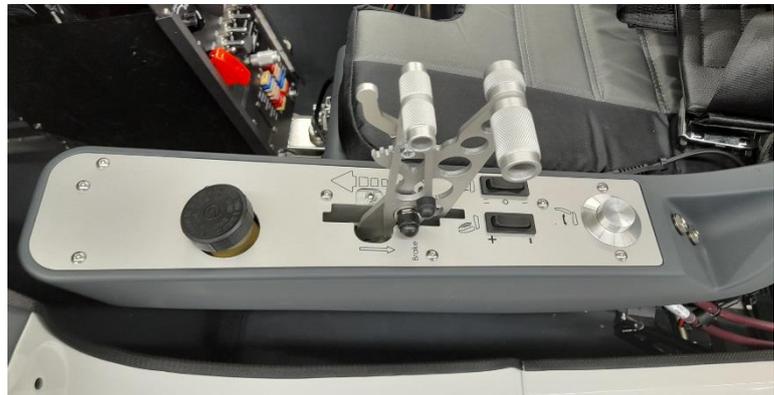
MTOsport 2017:

Access to the brake fluid reservoir is given easily on the MTO2017.

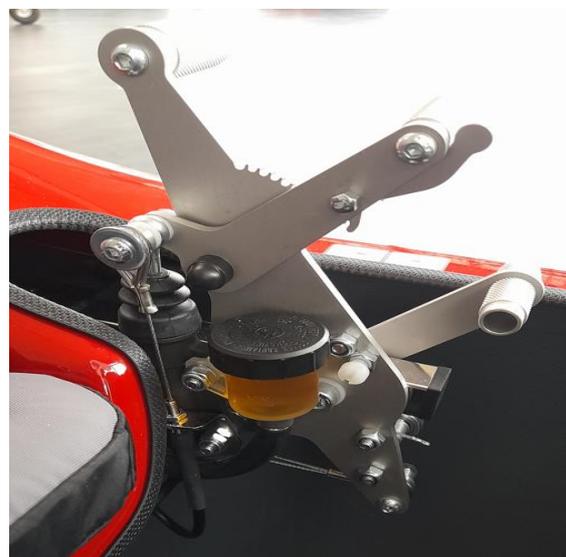
MTOsport 2010:

Like for the MTO2017 you can find the reservoir in the throttle/brake unit.

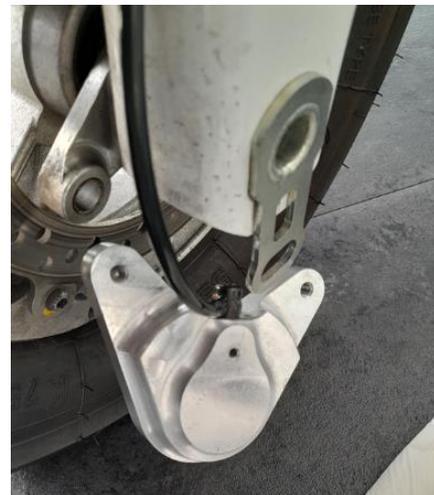
Remove the brake caliper from the brake assembly.

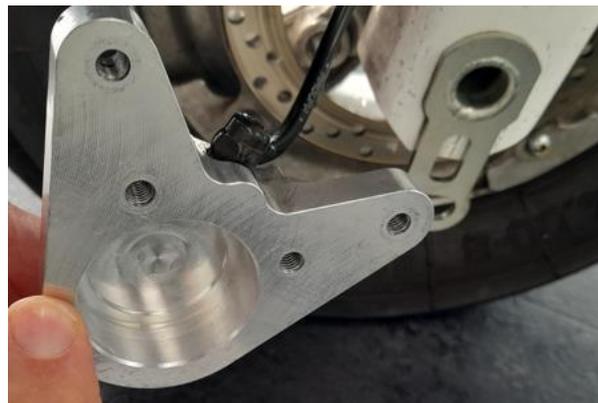
Remove the brake piston from the caliper, either by using the brake lever or using compressed air pushed through the vent screw hole.

Be careful to avoid brake fluid contamination of the brake pads and aircraft, and especially of painted parts.

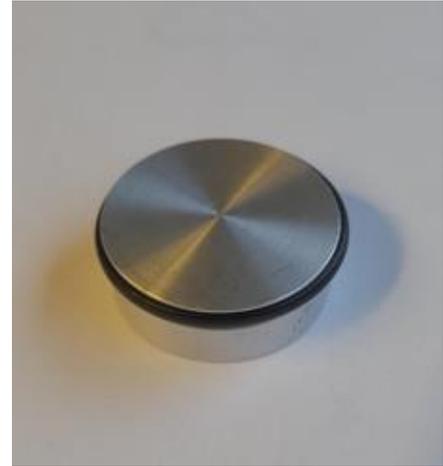
Remove the old O-ring and clean the brake piston.  
Apply brake cylinder paste into the groove, then insert the O-Ring and spread some paste on the surface of the brake piston and the O-ring.

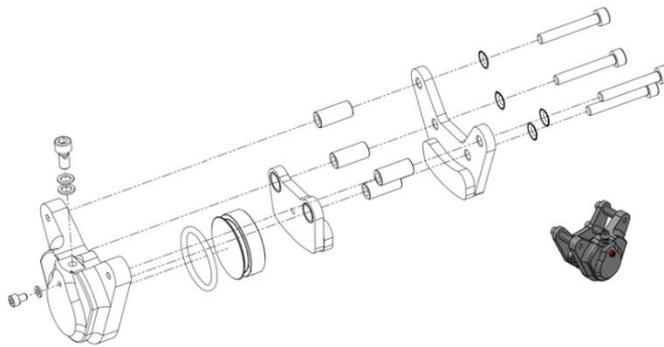
Re-install the components back together as per the respective AMM:  
Torque the vent screw only hand tight.

After reassembly bleed the brake system to ensure that it is free of air entrapment in accordance with normal brake bleeding processes. Tighten the vent screw after bleeding.
