| <b>Title: Torque / Washer Check L/H Lower Engine Mount Rotax 915 iS</b> | | |
| <b>AG-SB-2023-04-B-EN</b> | <b>Effective Date: 09.10.2023</b> | <b>Compliance Category:</b> |
| <b>Aircraft type &amp; model:</b><br><br><b>All aircraft with a Rotax 915 iS engine and a fixed nut on the left lower engine mount</b> | <b>Affected Serial number(s):</b><br><br><b>All aircraft</b> | |

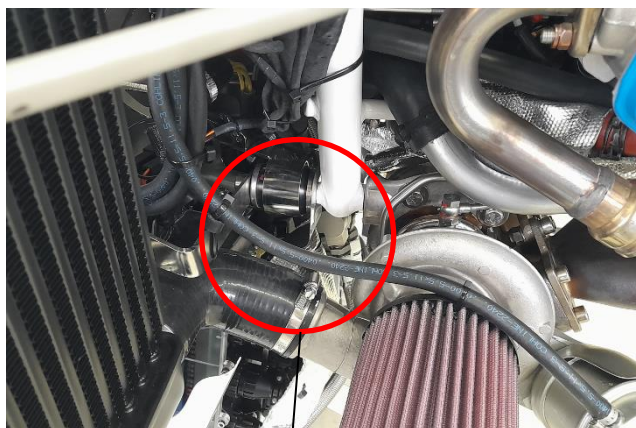
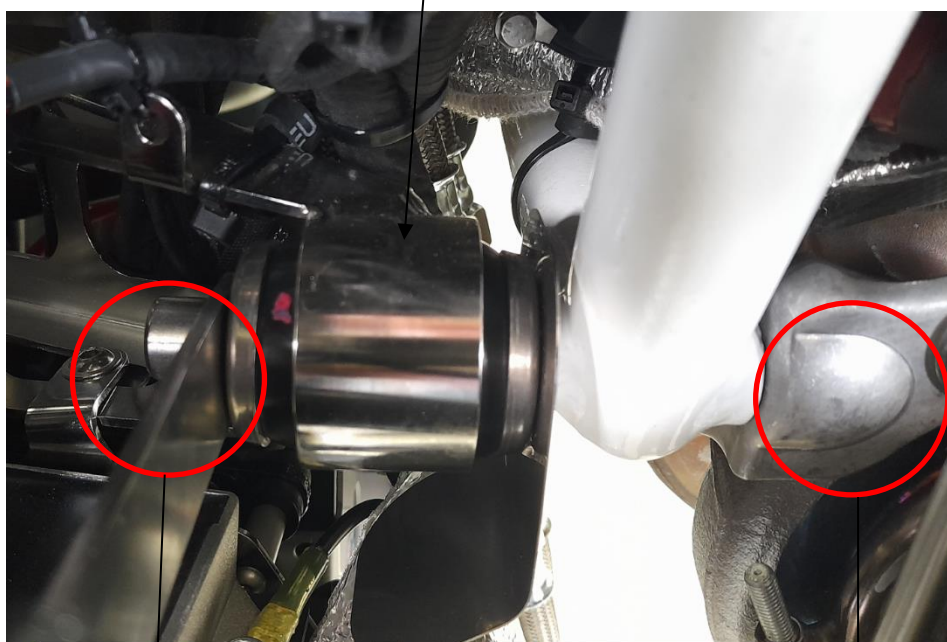
Bolt with Nord-Lock washer

If the aircraft is NOT fitted with a Nord-Lock washer on the lower left hand engine mount, carefully loosen the nut and remove the bolt. Support the engine with a crane or similar if necessary. Install the Nord-Lock washer (convex side facing bolt head) and put the bolt back in, release the engine from the crane if this has been done and torque the bolt with 56Nm.
