**AG-SB-2017-01-C-EN – Protection of the measuring lines of the shunts**

**Category C**

20.02.2017

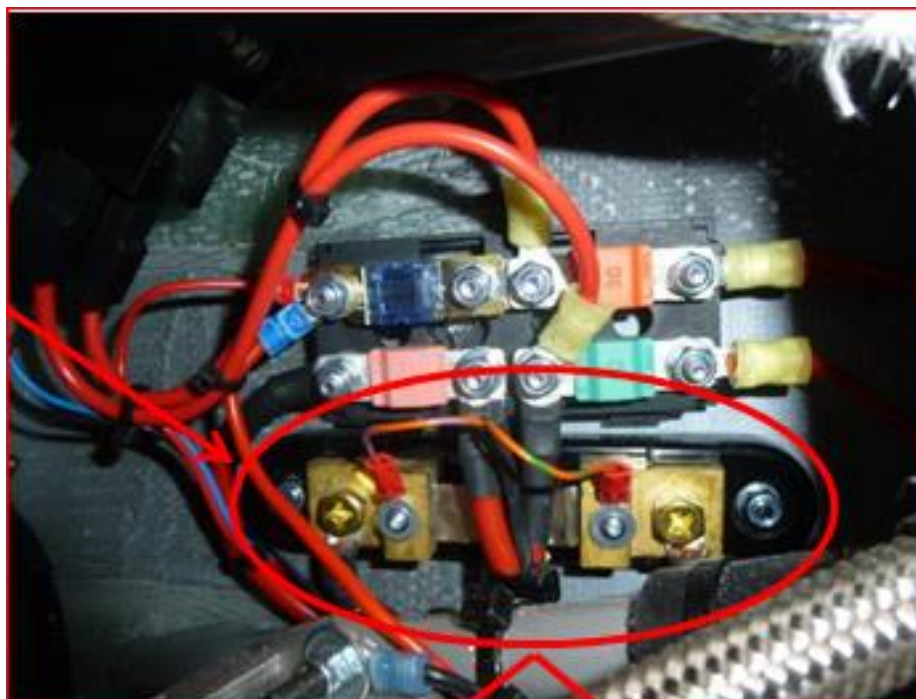
It has been found that the two Dynon shunt current measuring lines require additional safety fuses (see Fig. 1).

Fig 1: Shunt, old installation

- 1    Get access to the components by removing the engine cowlings, and inner firewall (Cavalon)
- 2    Disconnect the earth connection of the battery where convenient for access.
- 3    Disconnect both 0,35<sup>2</sup>mm cables from the shunt (see fig 1).
- 4    Remove the ring terminals from the cables, leaving a length of bared cable approx 5mm long.
- 5    Insert the bared cable into Article 44243, and crimp in place. Ensure that the crimps are secure, and then shrink the shrink sleeve with a hot-air gun.
- 6    Reattach the cables to the shunt, and tighten the nuts securely.
- 7    Reconnect the battery where disconnected.
- 8    Securely refit any removed access panels, firewall and cowlings.

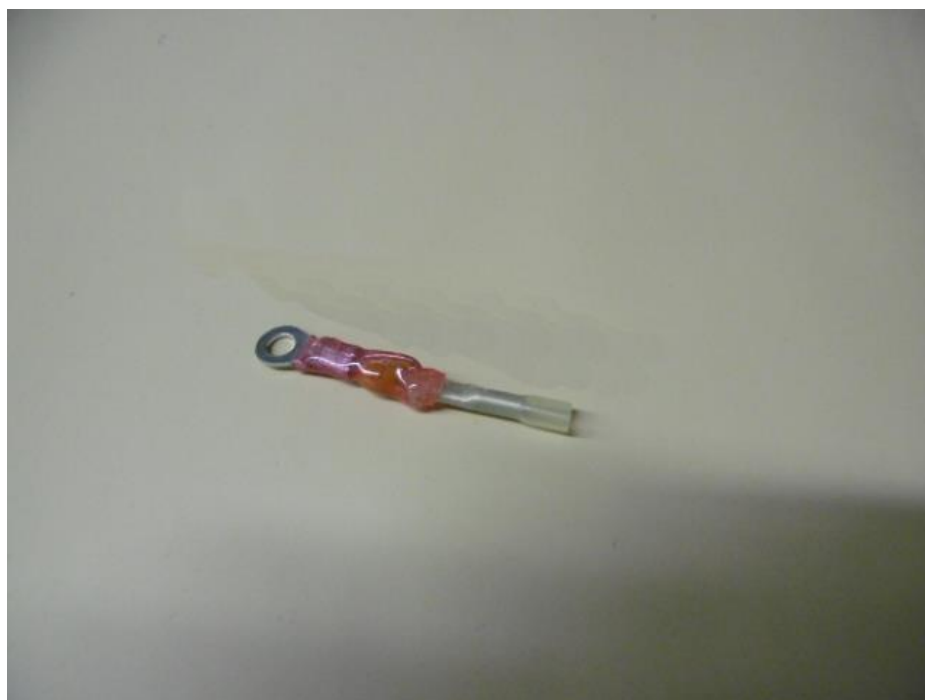
Fig 2: part no. 44243 - Shunt wiring protection

- Retrofitting of two additional fuses (In Wire fuse suitable for the cable cross-section).

24-00-00-V-44243 (L1) Shunt wiring protection

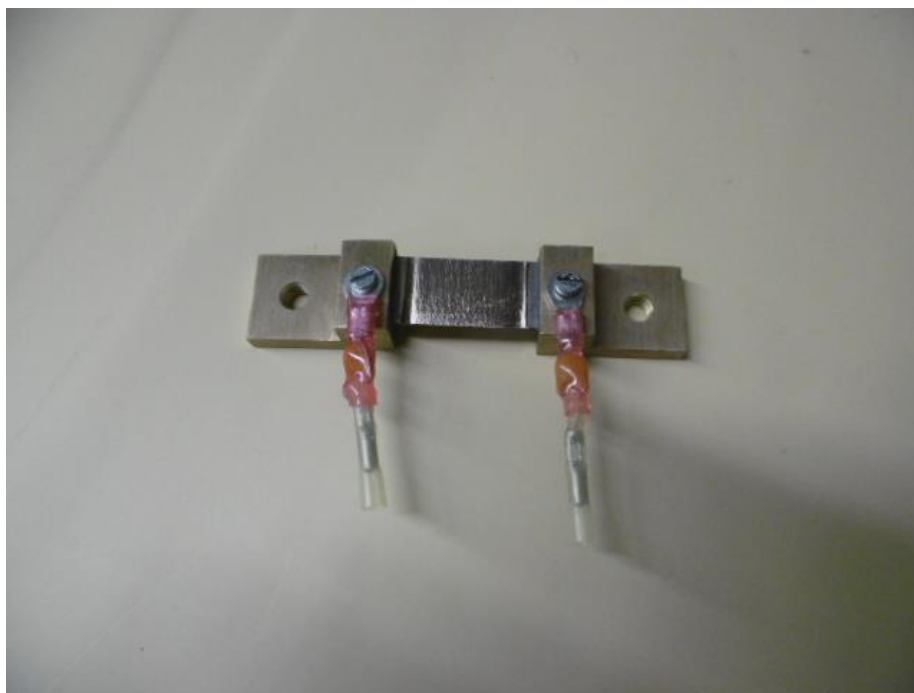
**Fig 3: Shunt, new installation**

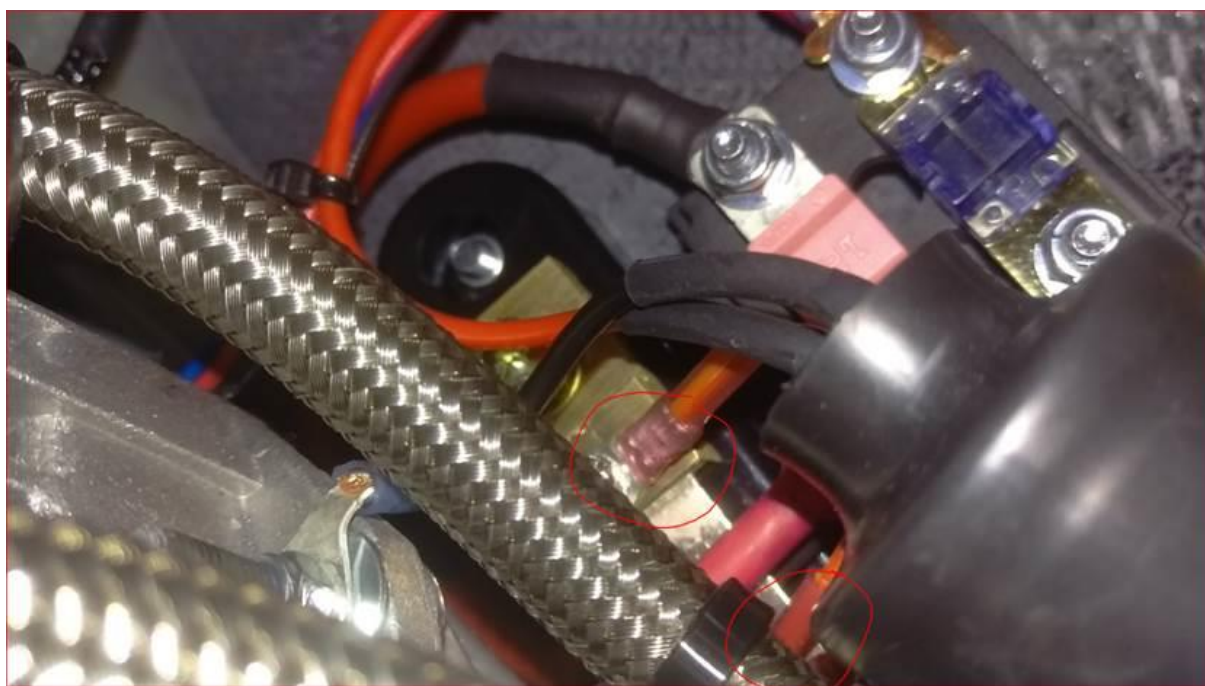
**Fig 4: Shunt, new Installation**
