| <b>Title: IVO Propeller - Lubrication of Shaft</b> | | |
| <b>AG-SIL-2018-04-B-EN</b> | | <b>Compliance Category:</b> |
| <b>Aircraft type &amp; model:</b><br>All aircraft fitted with an IVO propeller | <b>Affected aircraft serial numbers:</b><br>All aircraft fitted with an IVO propeller | |

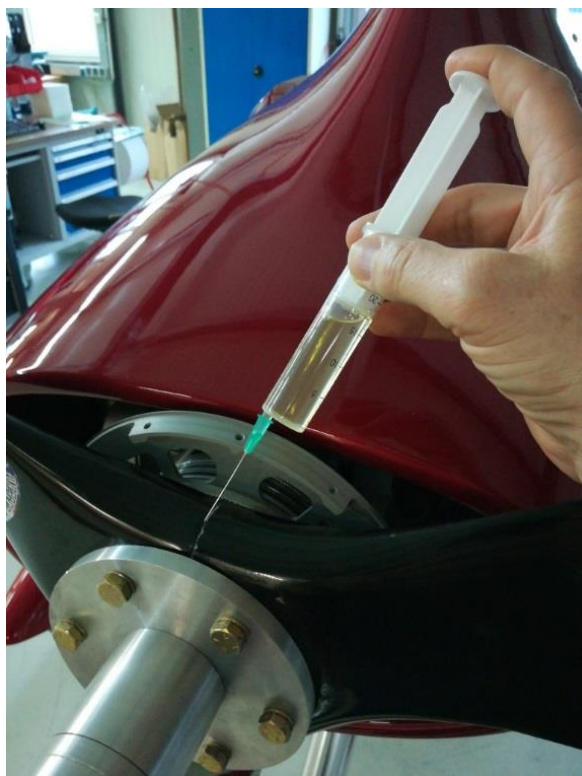
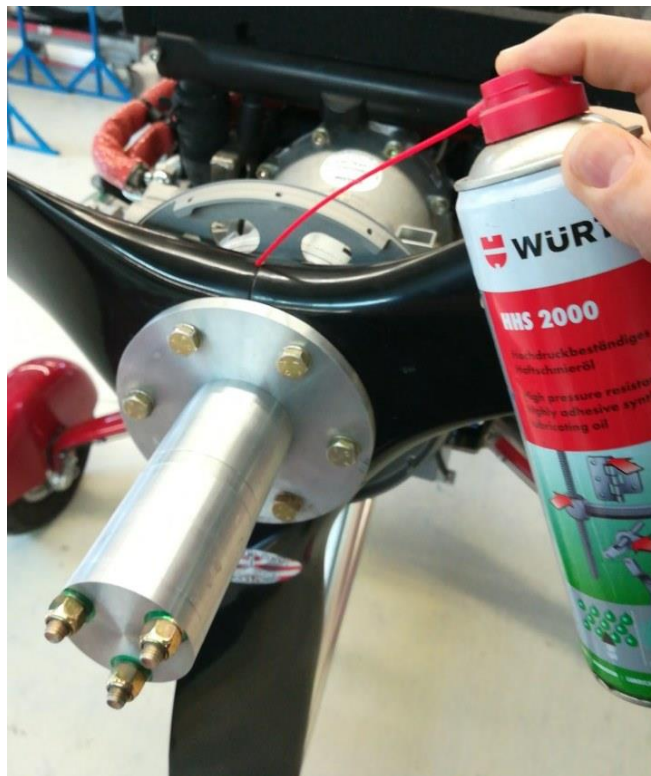
*Position without spinner*

1. Gain access to the gap between the propeller blades. Where a spinner is fitted, and if required, remove upper engine cowlings to gain access to the forward face of the spinner plate.

2. Ensure that the gap between one pair of blades is uppermost (two blades are in ten-to-two position)
3. Using a suitable implement, liberally introduce the lubricant into the gap between the blade roots (accessing through the holes in the spinner plate if fitted). Ensure no lubricant contaminates the brush slip ring contact plates of the IVO propeller – thoroughly clean if contaminated.

4. Turn the prop 120° and repeat steps 2 and 3. Repeat this step one final time
5. Ensure the area around the propeller is clear, turn on the aircraft power supply and operate the coarse/fine rocker switch (connect an external power source to the aircraft if required)

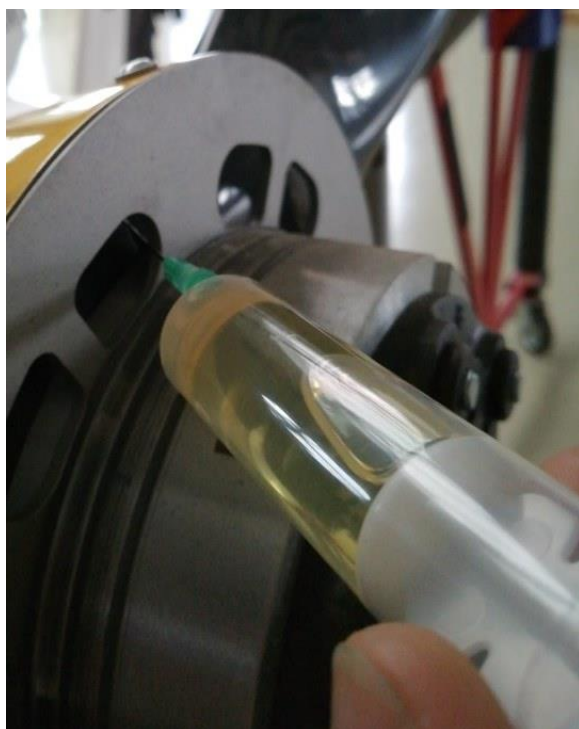
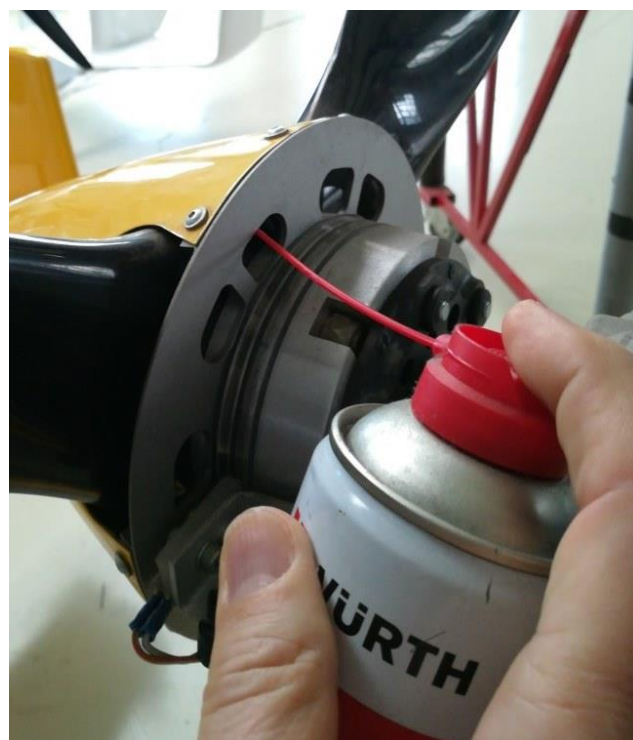
*Position with spinner*

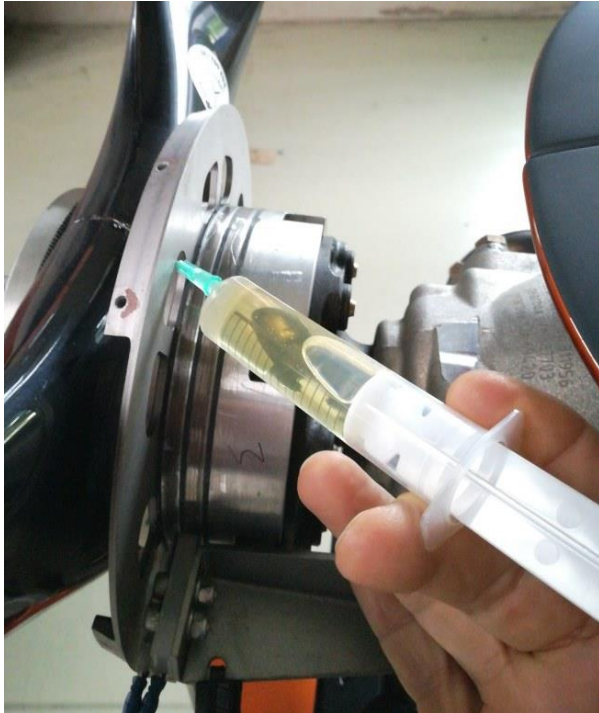
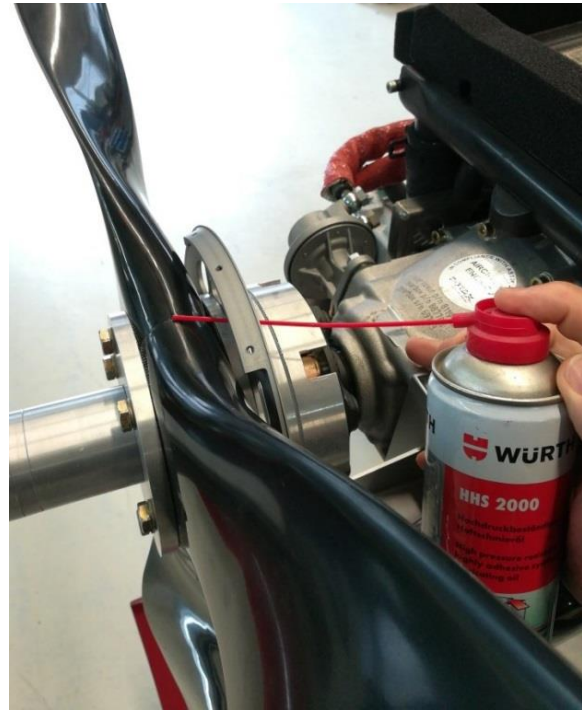
***Position with spinner (spinner removed for visual purposes)  
These photos demonstrate two alternative methods of introducing lubricant, either with Ballistol via a syringe or HHS2000 as a pressurised spray.***

Consumables used:  
Recommended lubricants as follows:  
Ballistol Universal 5L (88-00-00-S-40495)  
HHS2000 spray lubricant  
Or local equivalent low viscosity lubricant.
