Title: Bosch Fuel Filter F5273 Replacement Item F5316		
AG-SIL-2021-01-EN		Released:
Applicability		
Aircraft type & model:	Affected Serial number(s):	14 Jan 2021
MTO2017	All MTO2017 Models	
The maintenance manual to be referenced is this stated or subsequent issue.		As per AutoGyro website
<p>This form is the response from AutoGyro GmbH either against a problem found in the product in service requiring a containment or rectification action, or as service information for aircraft modification incorporation. For help, contact AutoGyro on 49(0)5121 88056-00, or email airworthiness@auto-gyro.com.</p>

Reason and overview of the Service Information Letter

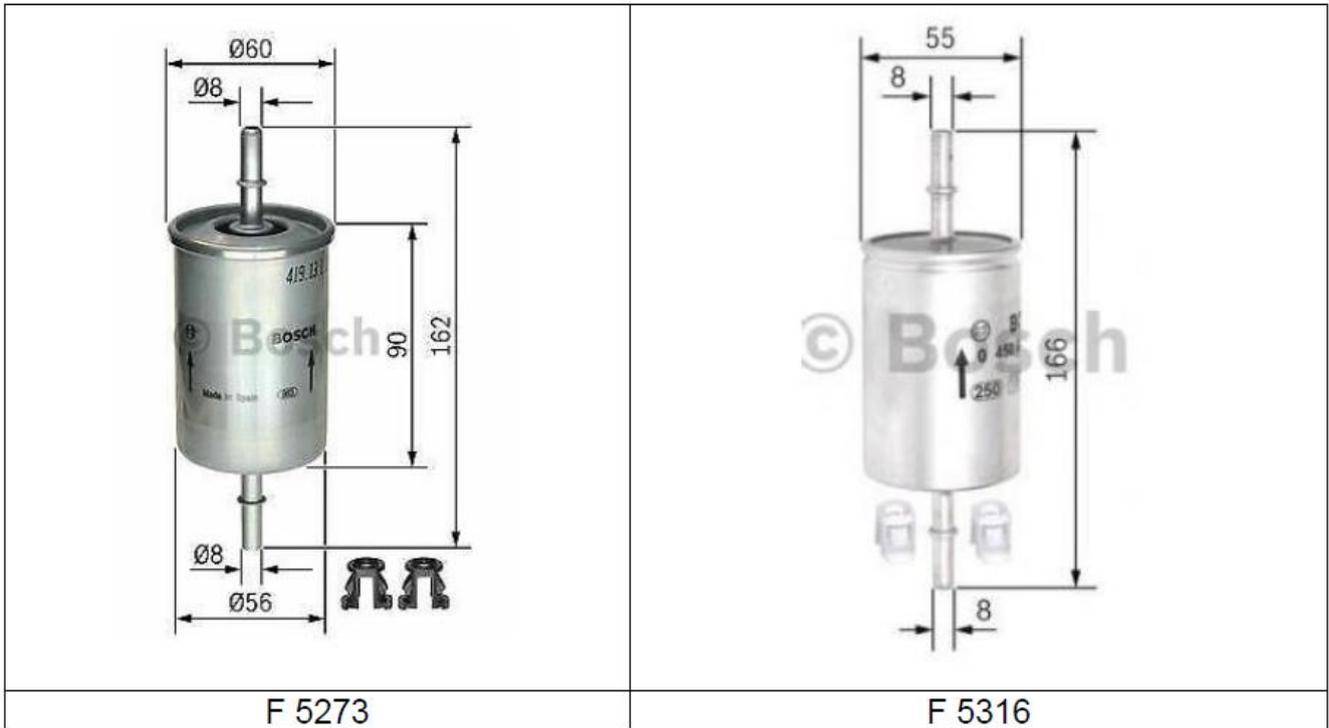
The F5316 filter is a one-for-one replacement for the F5273 in accordance with job card 28-20-00 8-1 in the relevant AMM. As can be seen from the illustration below, the differences are minimal. There is no requirement for adaptation or replacement of any originally assembled parts.
