| <b>Title: Super B Battery replacement with SBS 8 Battery</b> | | |
| <b>AG-SB-2018-06-B-EN</b> | | <b>Compliance Category:</b> |
| <b>Aircraft type &amp; model:</b><br>All models with Super B Battery fitted | <b>Affected Serial number(s):</b><br>All models with Super B Battery fitted | |

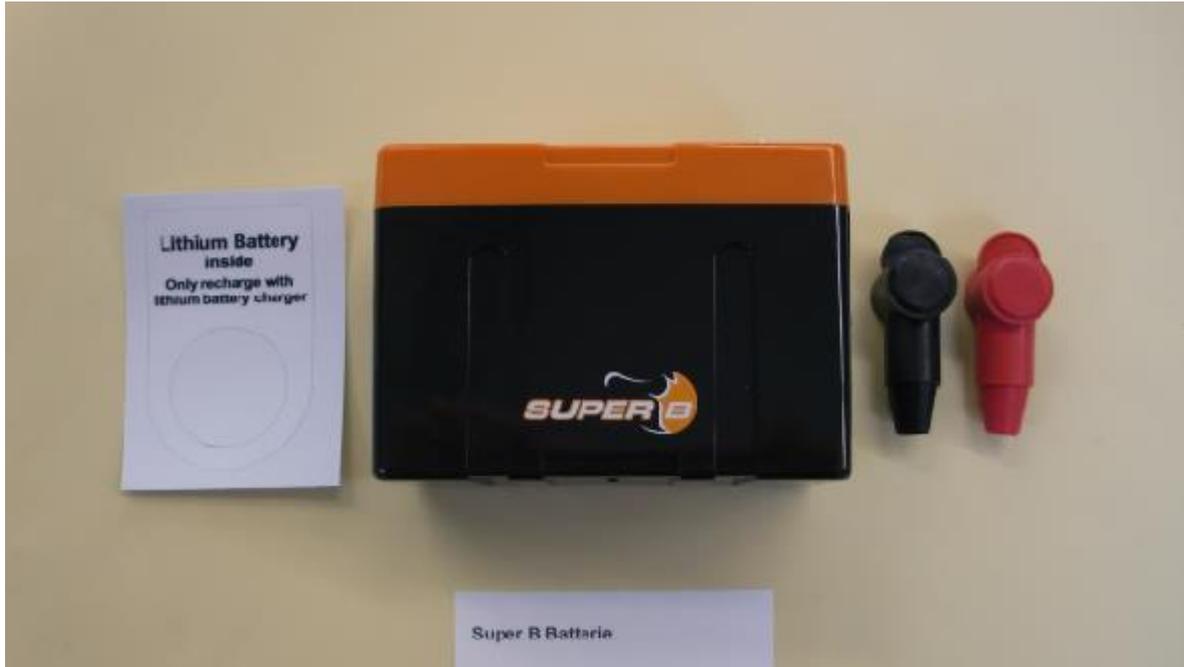
Super B battery

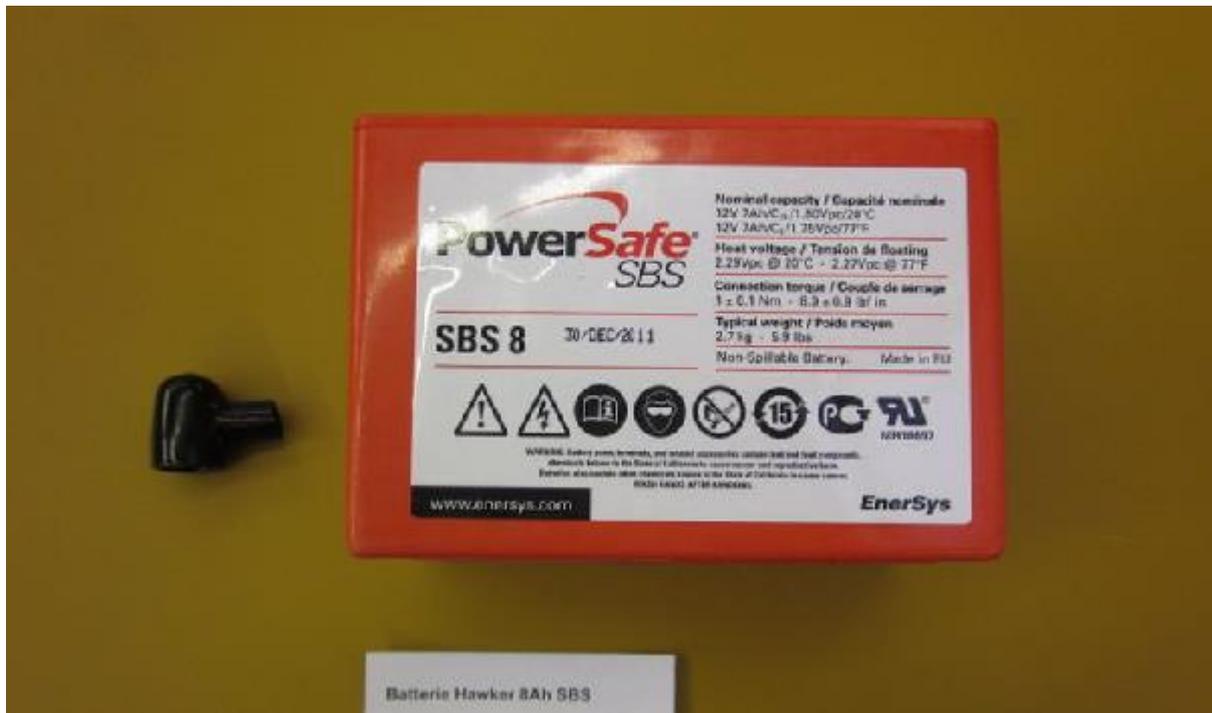
Hawker SBS 8
