AG-SB-2017-02-C-EN – Calidus compressor fuse

Category C

28.02.2017

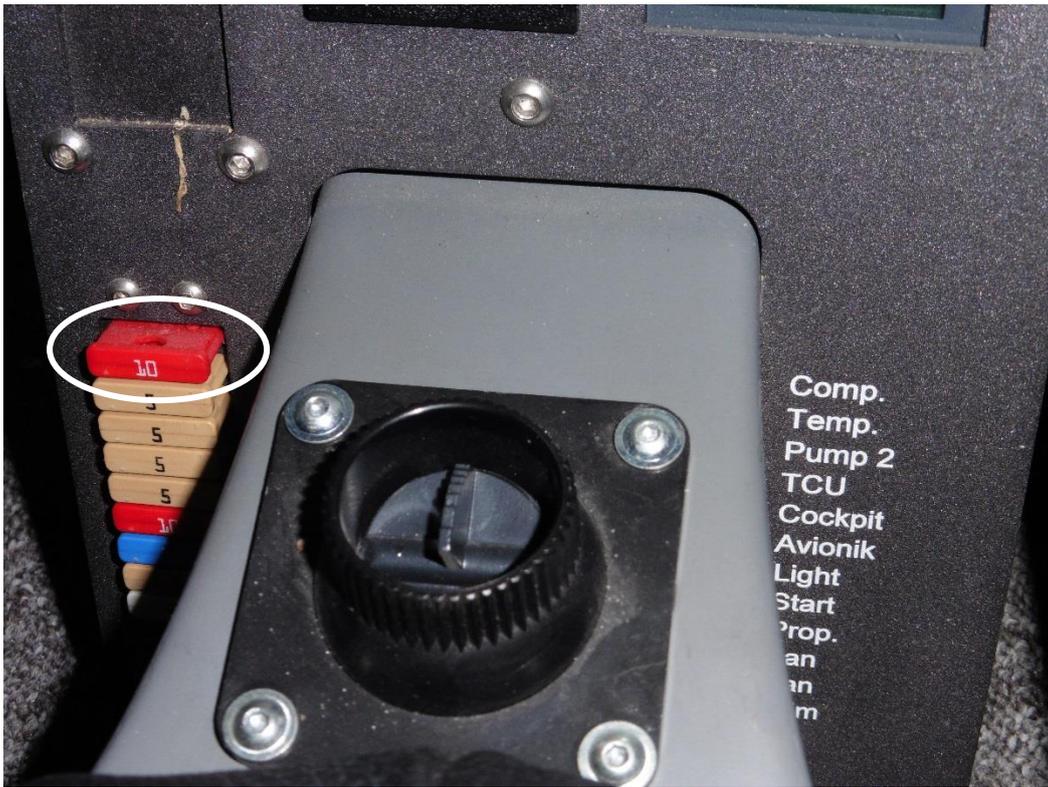
Fig. 1: 10A Fuse Compressor

Production quality control checks have determined that variability in the current required to start the compressor could be in excess of the circuit 10A fuse, causing it to blow. Whilst there have been no recorded fuse blows in service, this bulletin highlights this potential and provides a preventative service fix.

- 1 Remove the 10A fuse for the compressor from the slot.
- 2 Insert the 15A fuse into the compressor slot
